# Concrete Channels- A Return to Naturalized Streams in Urban Environments

Melissa Ryan  
City of Kitchener

Steve Brown  
Stantec Consulting

March 26, 2015

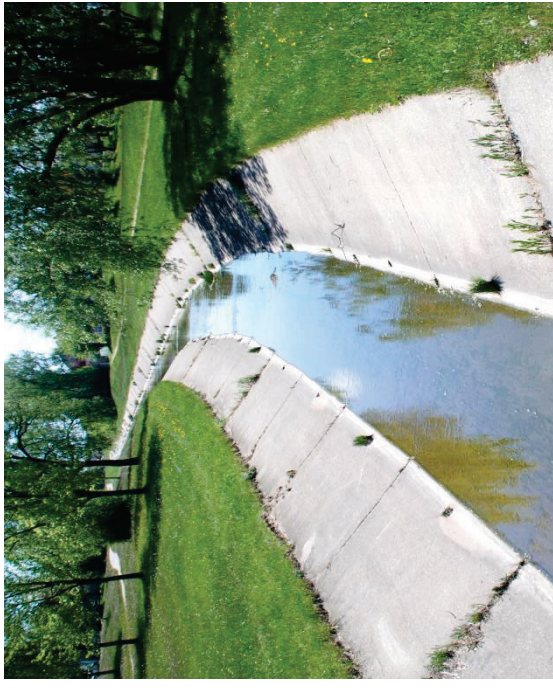
- Existing Conditions:

- ~ 2,500 m of steep concrete channel (up to 2%)
- Tributary area ~12 km<sup>2</sup>
- Urban land uses
