TRIECA | 2019 CONFERENCE

From Design to Construction: Lessons Learned from Contractor Inexperience During Implementation of Erosion Mitigation at the Oshawa Landfill

Robin McKillop, M.Sc., P.Geo.
TRIECA conference
March 20, 2019

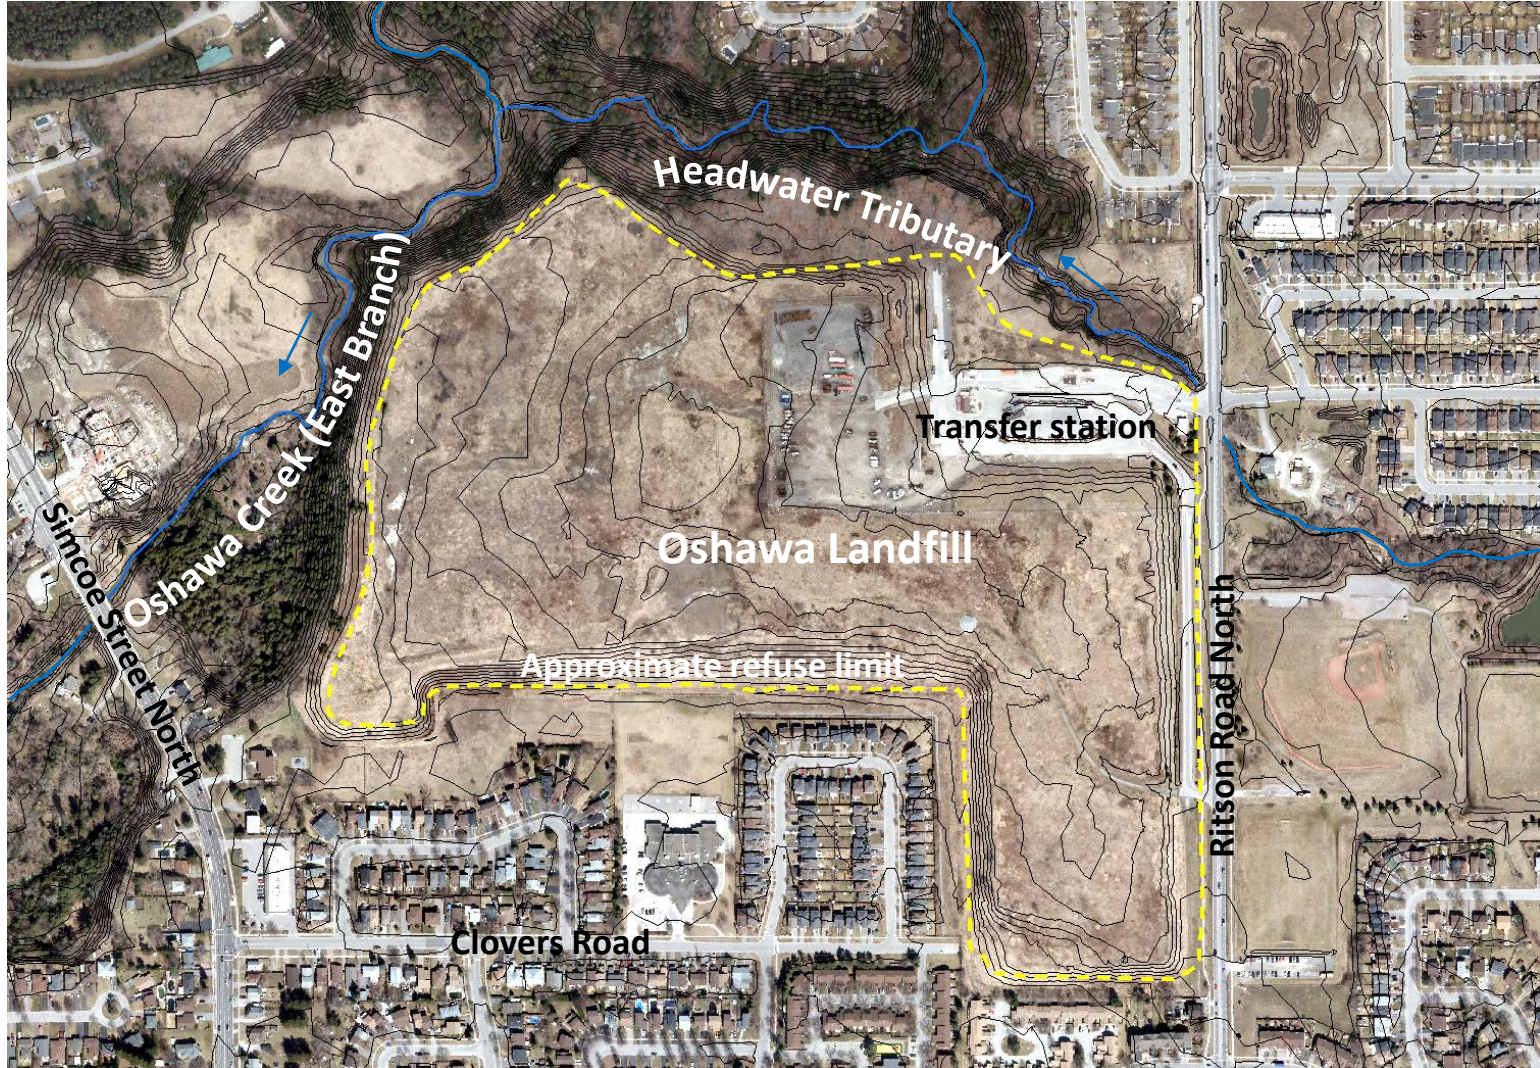
Oshawa Landfill

Erosion!

- Surface runoff (gullying)
- Fluvial scour
- Slope instability

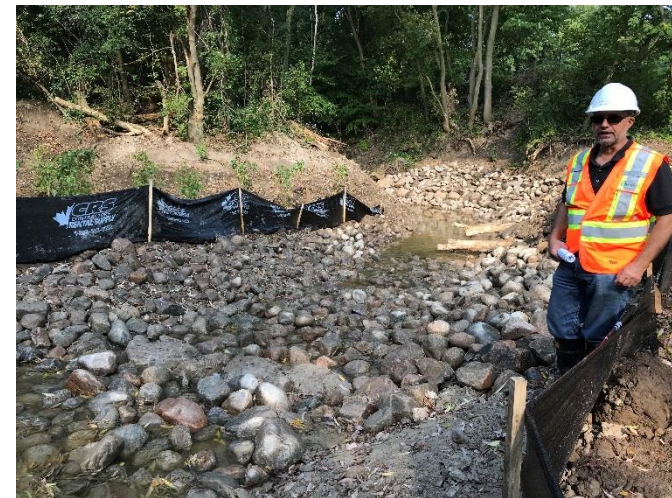
Site 1

Embedded woody debris

Riparian shrub plantings along regraded slope toe

Pool

Benched inner bank (improved floodplain accessibility)

Cobble riffle

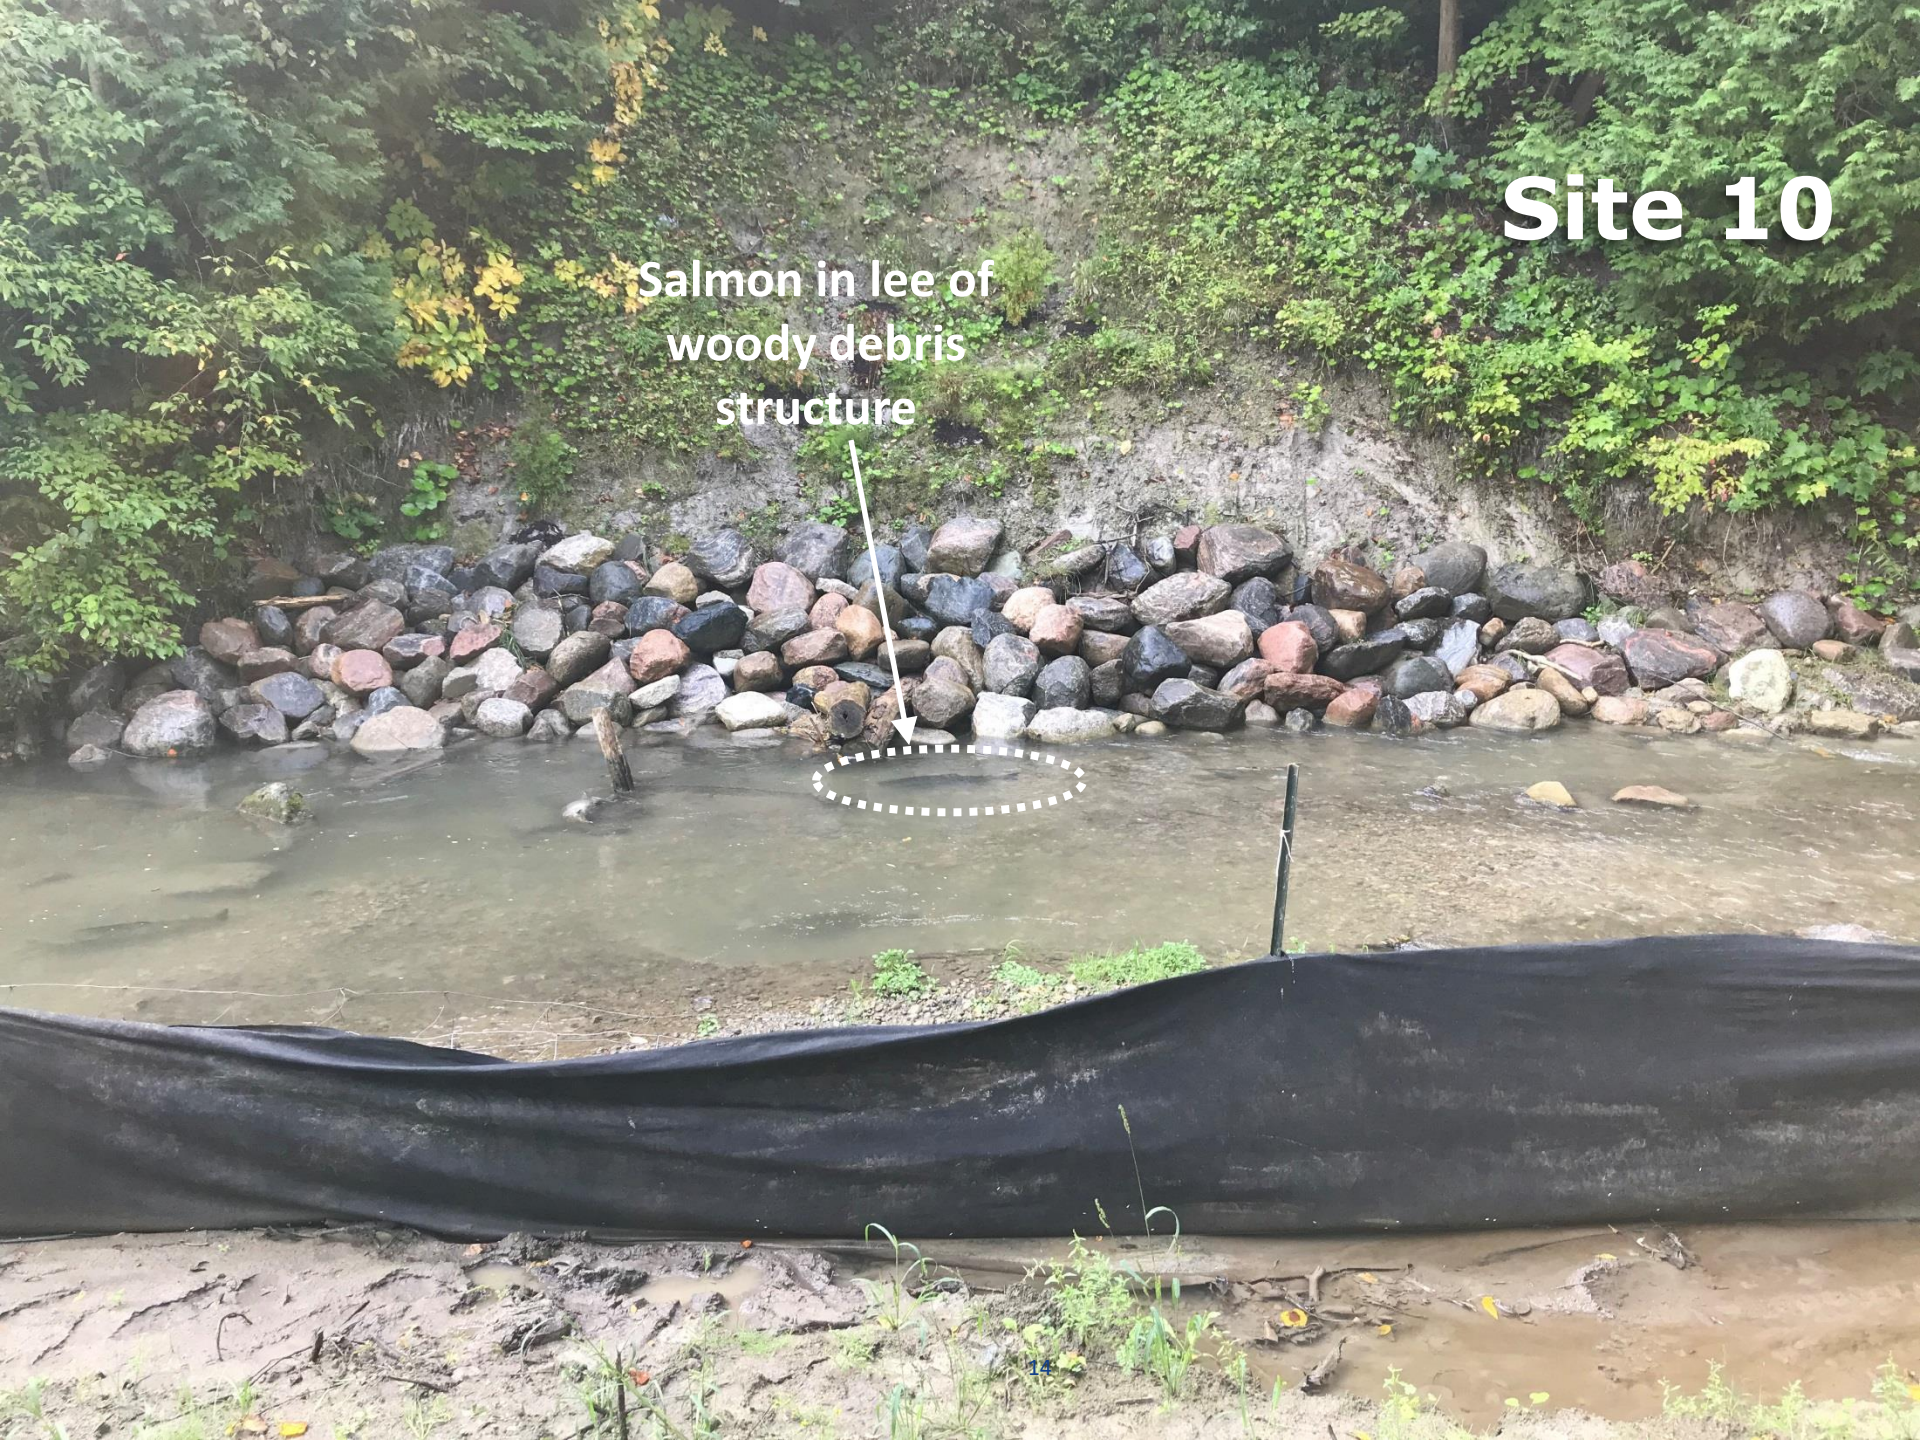
Site 10

Salmon in lee of
woody debris
structure

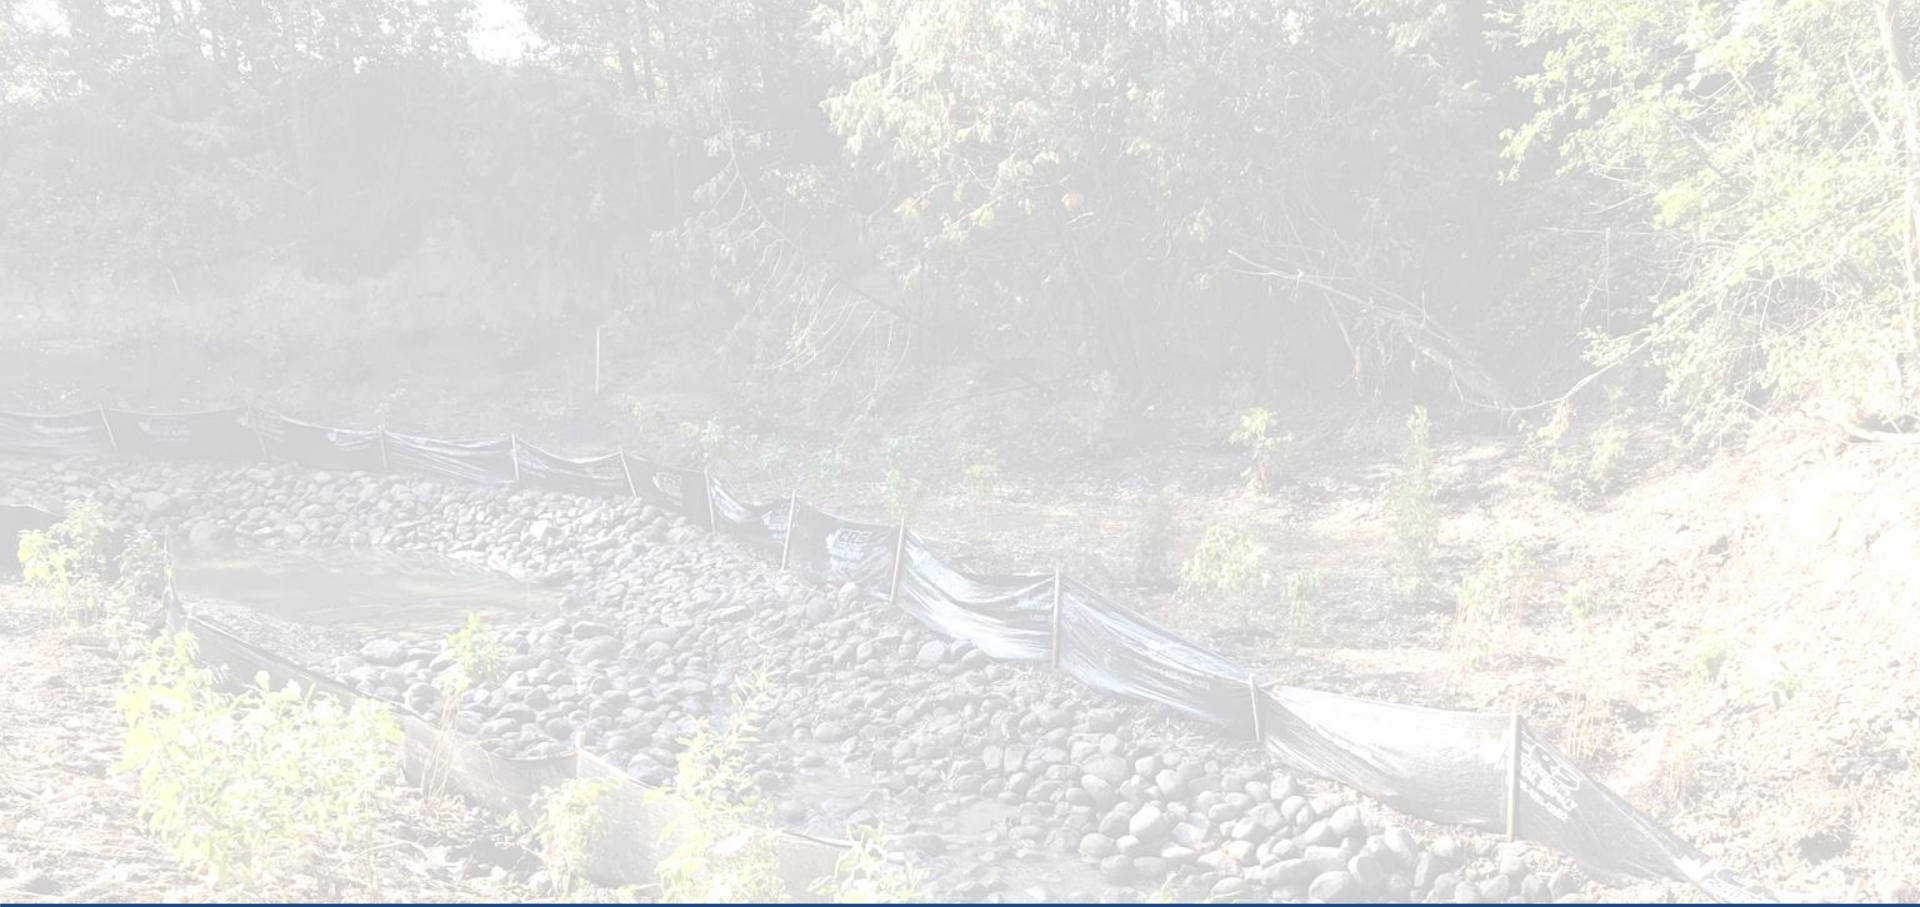
Site 11

Living cedars
retained in slope-
toe protection

Embedded woody
debris

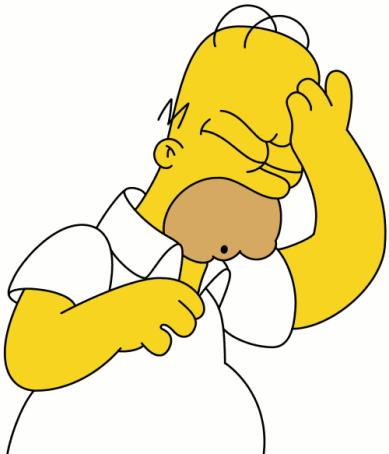
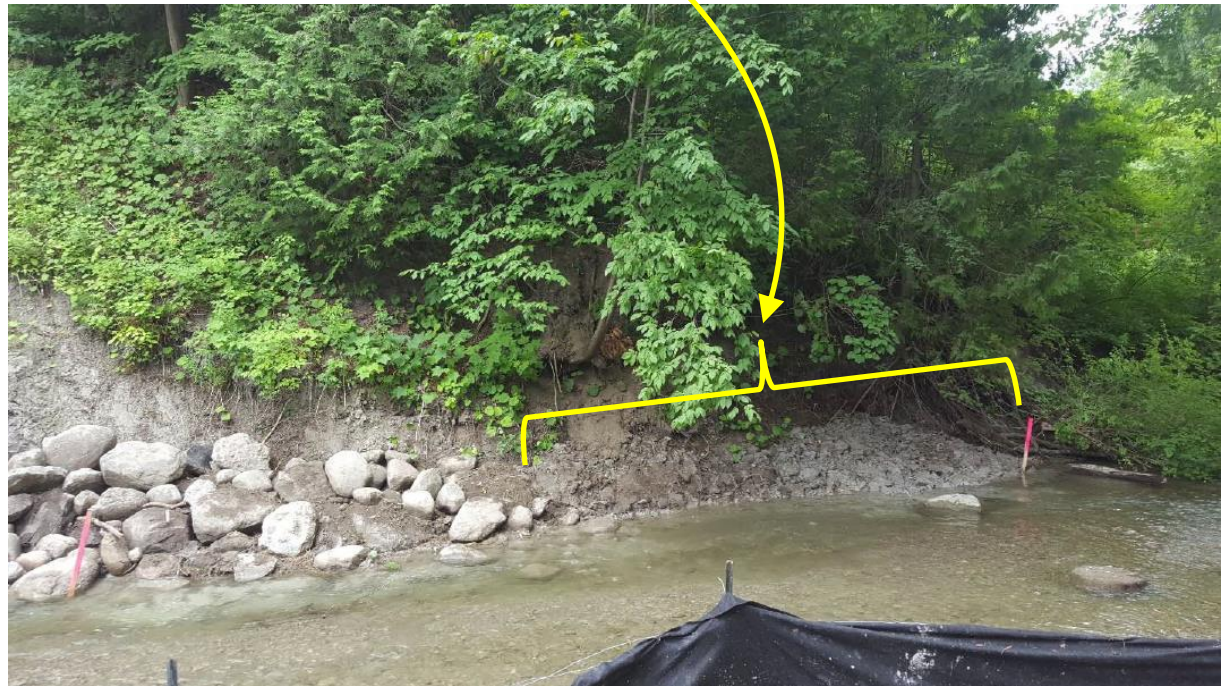
Design implementation issues

- Riparian plantings installed on wrong (inner) bank
- Native clay/silt fill placed along toe of bank at downstream tie-in
 - Shared responsibility – e.g. too few XSs
