# Tremaine Road Extension from Steeles Avenue to No. 3 Side Road, Milton, Ontario: Managing Complex Environmental Challenges through Careful Planning and Monitoring

WSP Canada Group Limited

Project Owner: Regional Municipality of Halton

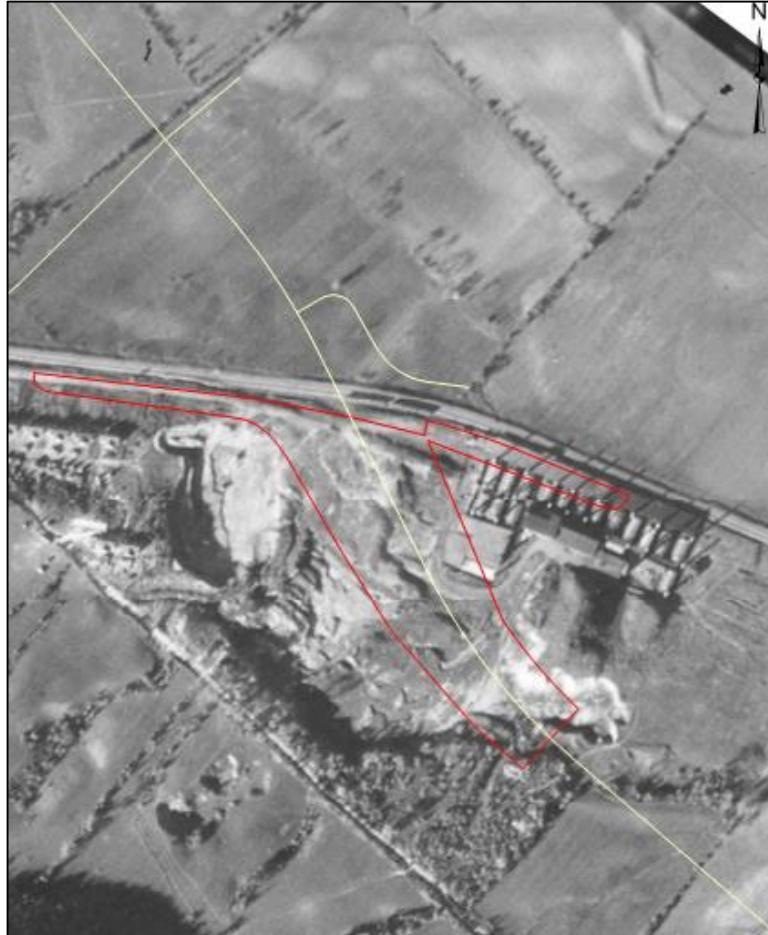
1934 aerial photograph showing the historical brick works and shale quarry

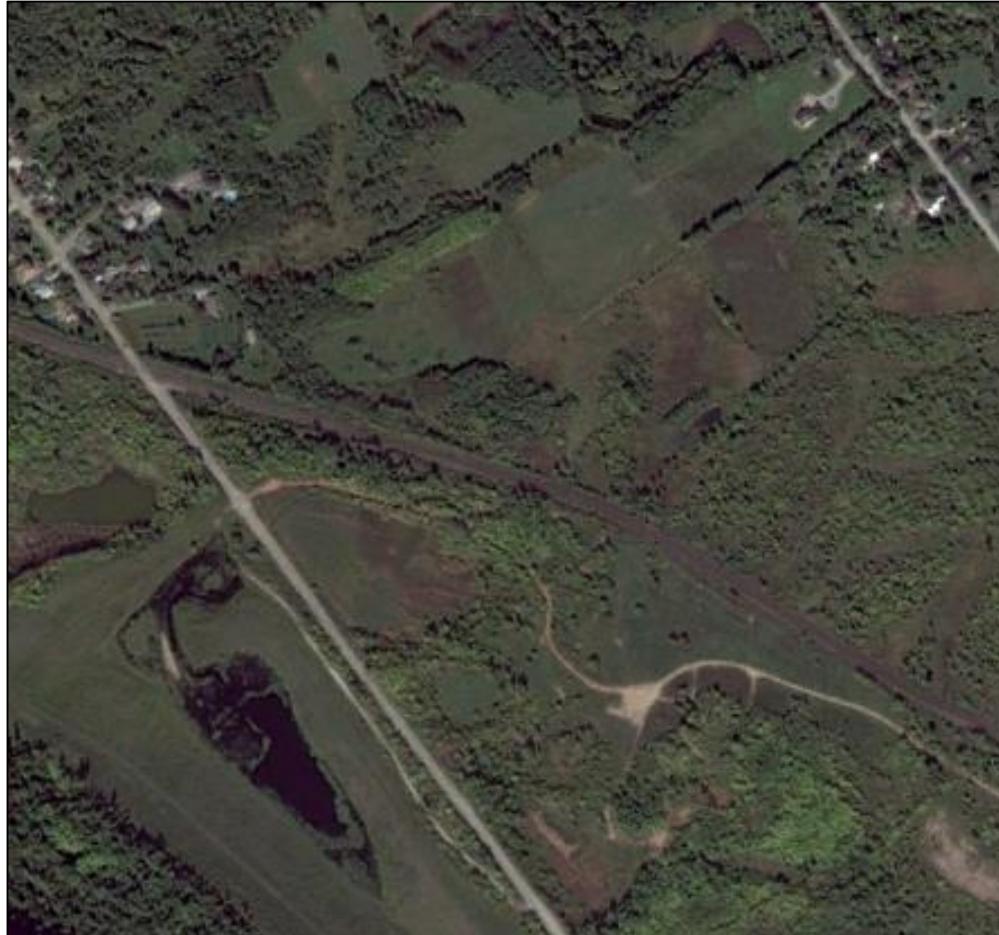
September 2016 Google Earth Image of the Same Area

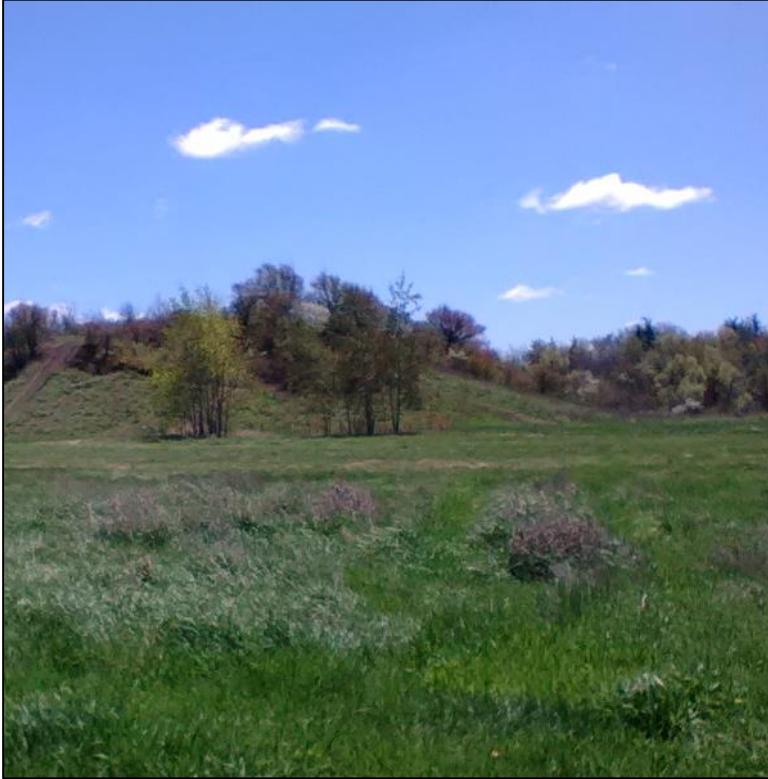
Former brick works, now covered by earth fill mixed with bricks.

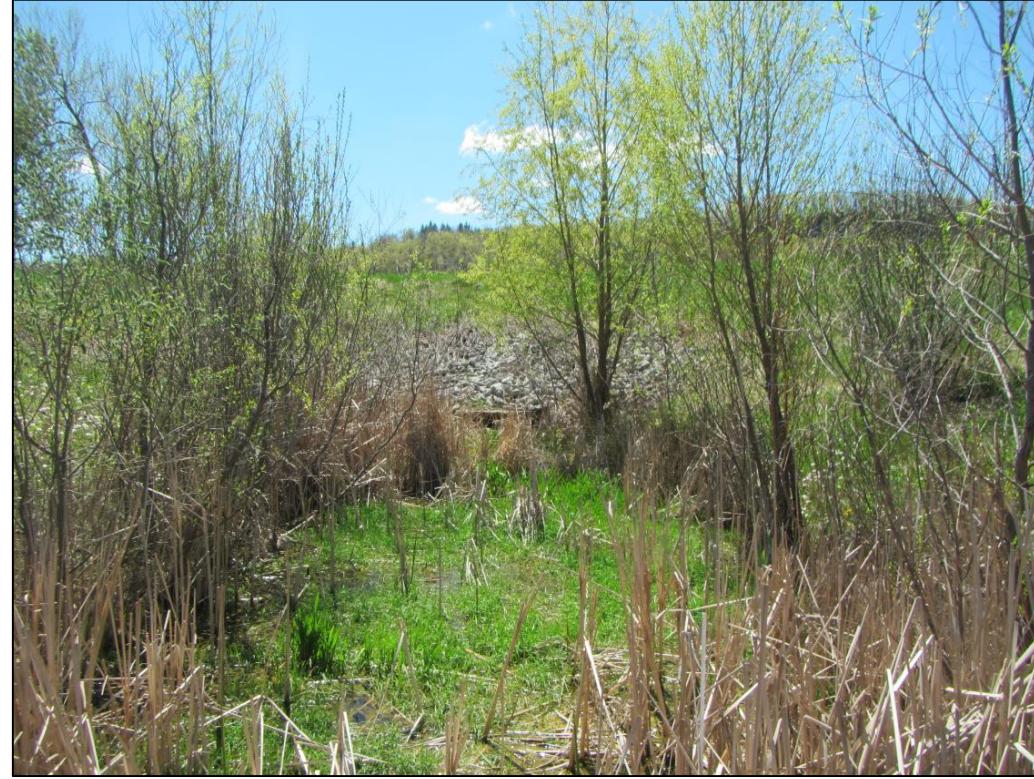
Drainage culverts under brick fill areas, Long forgotten about.

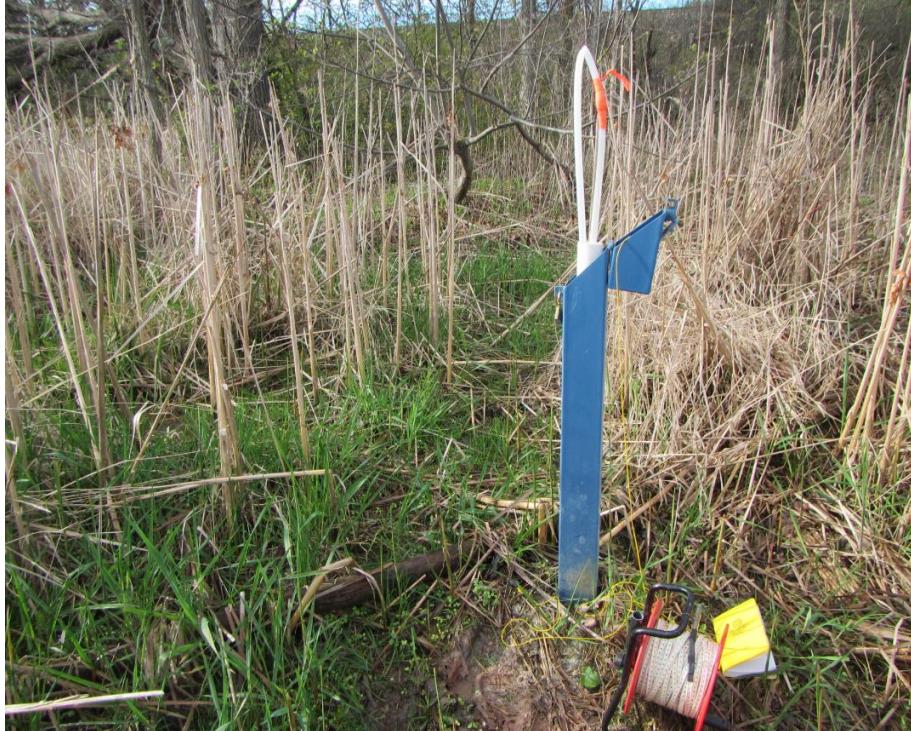
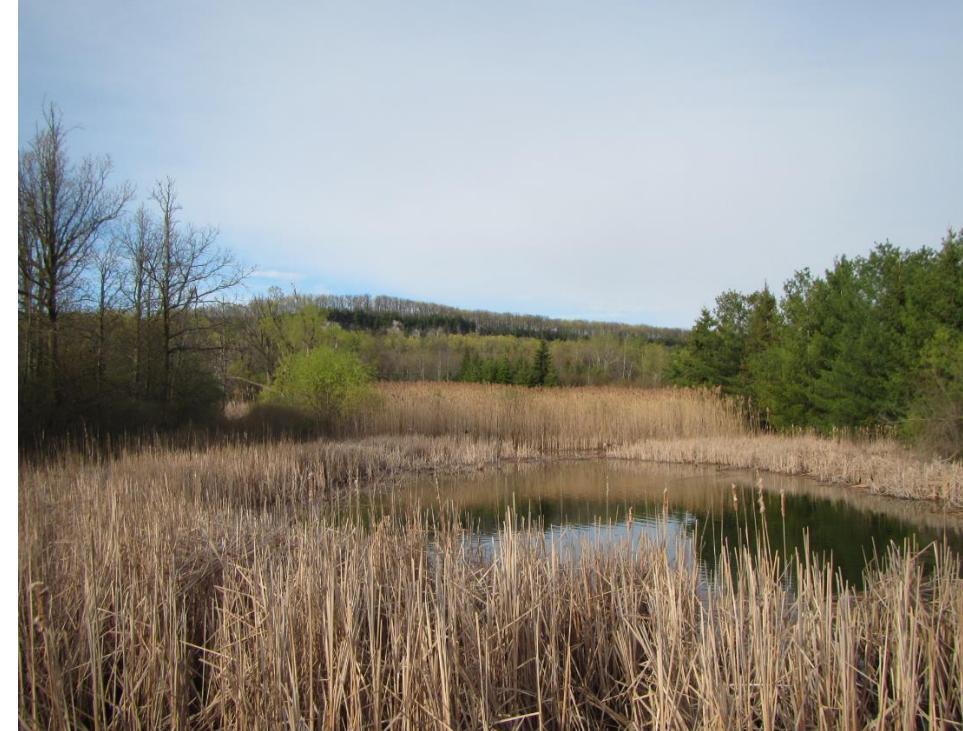
Wetlands north (down slope) from the Canadian Pacific Railway Tracks sustained by groundwater discharge.

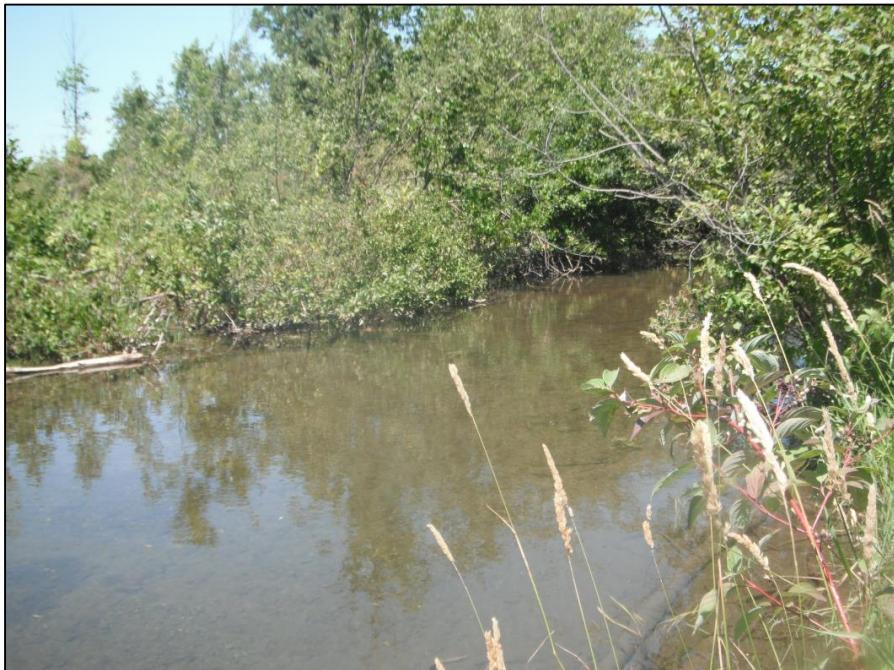
Sixteen Mile Creek Crossing

Ground view, July 2018

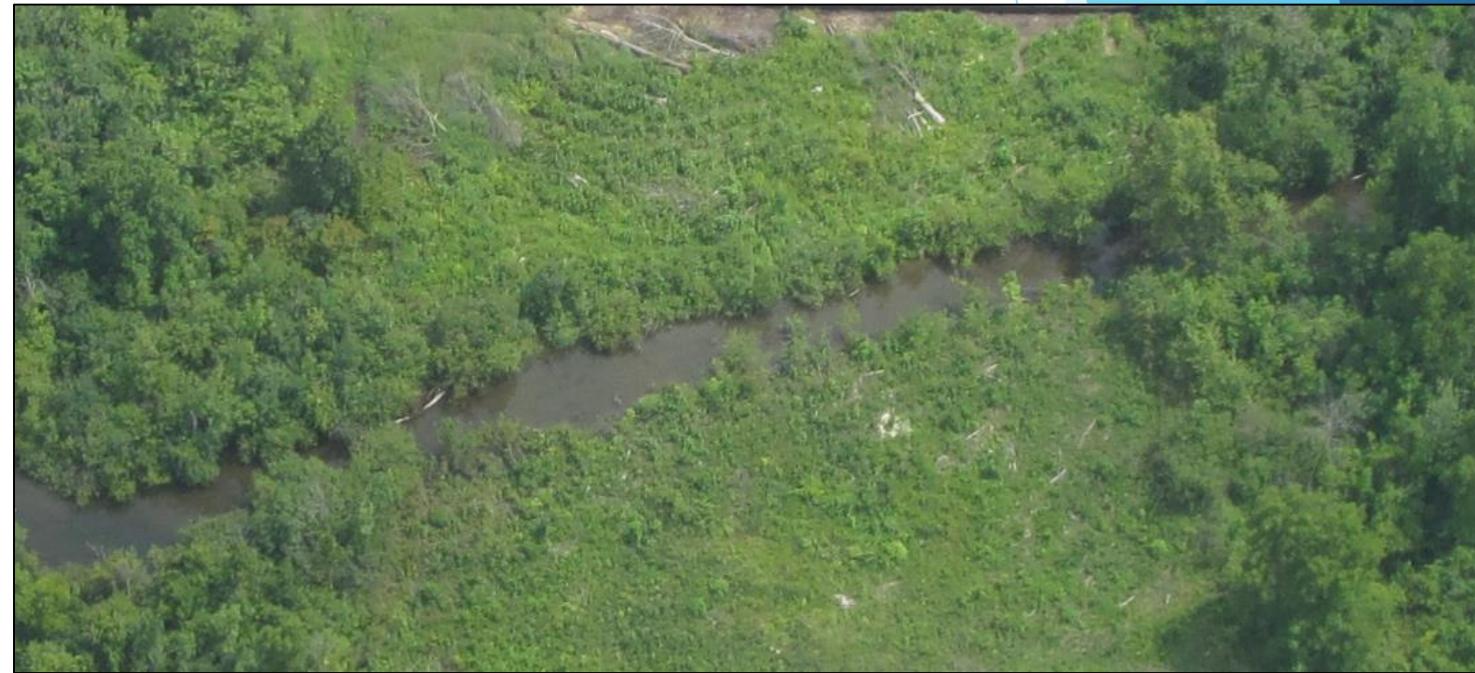
Aerial view, July 2018

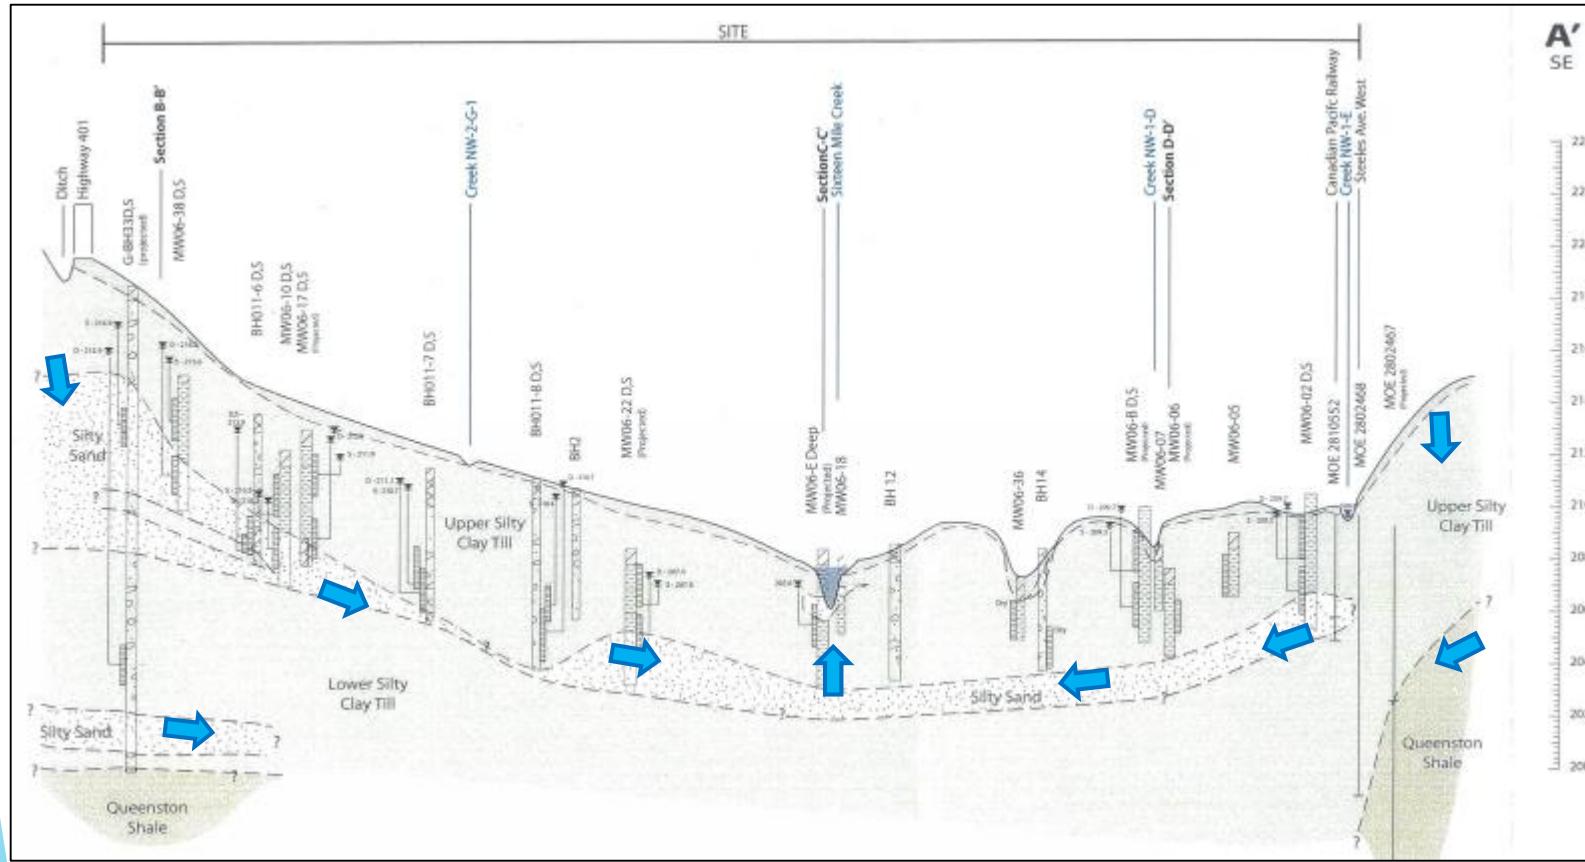
Interpreted  
Groundwater  
Flow  
Direction

Extensive geological and hydrogeological investigations done by AMEC (2003) on behalf of Milton Heights Landowners Group

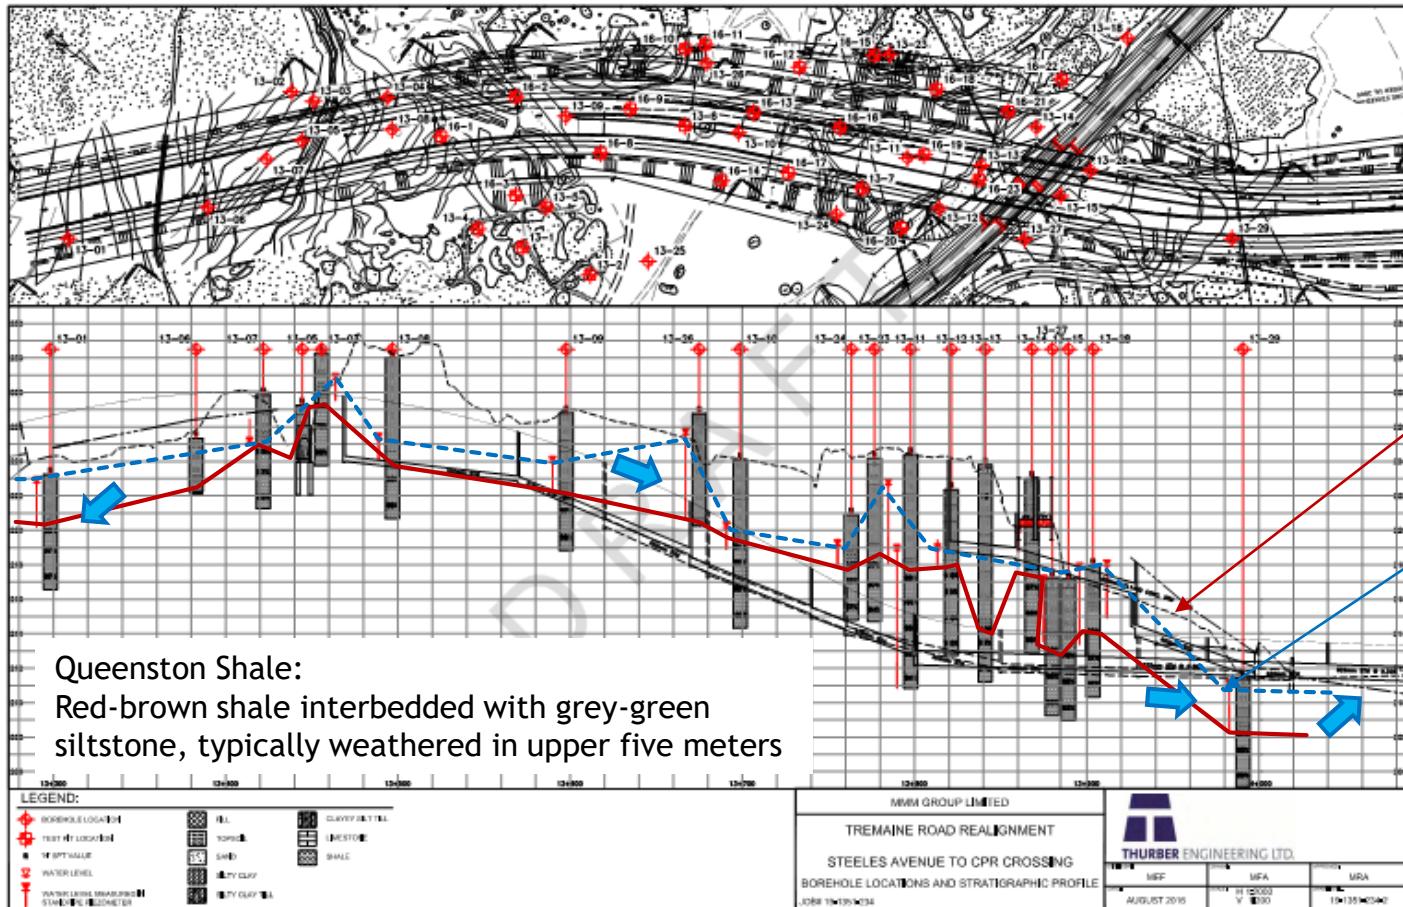
- Earth Fill:
  - Silt, Clay, Ground-up Shale and Brick Rubble

## Perched Groundwater in the Earth Fill Unit, Regional Aquifer in the Upper Weathered Shale

## Interpreted Groundwater Flow Direction

Geological Cross Section Prepared by Thurber Engineering Limited  
(August 2016)

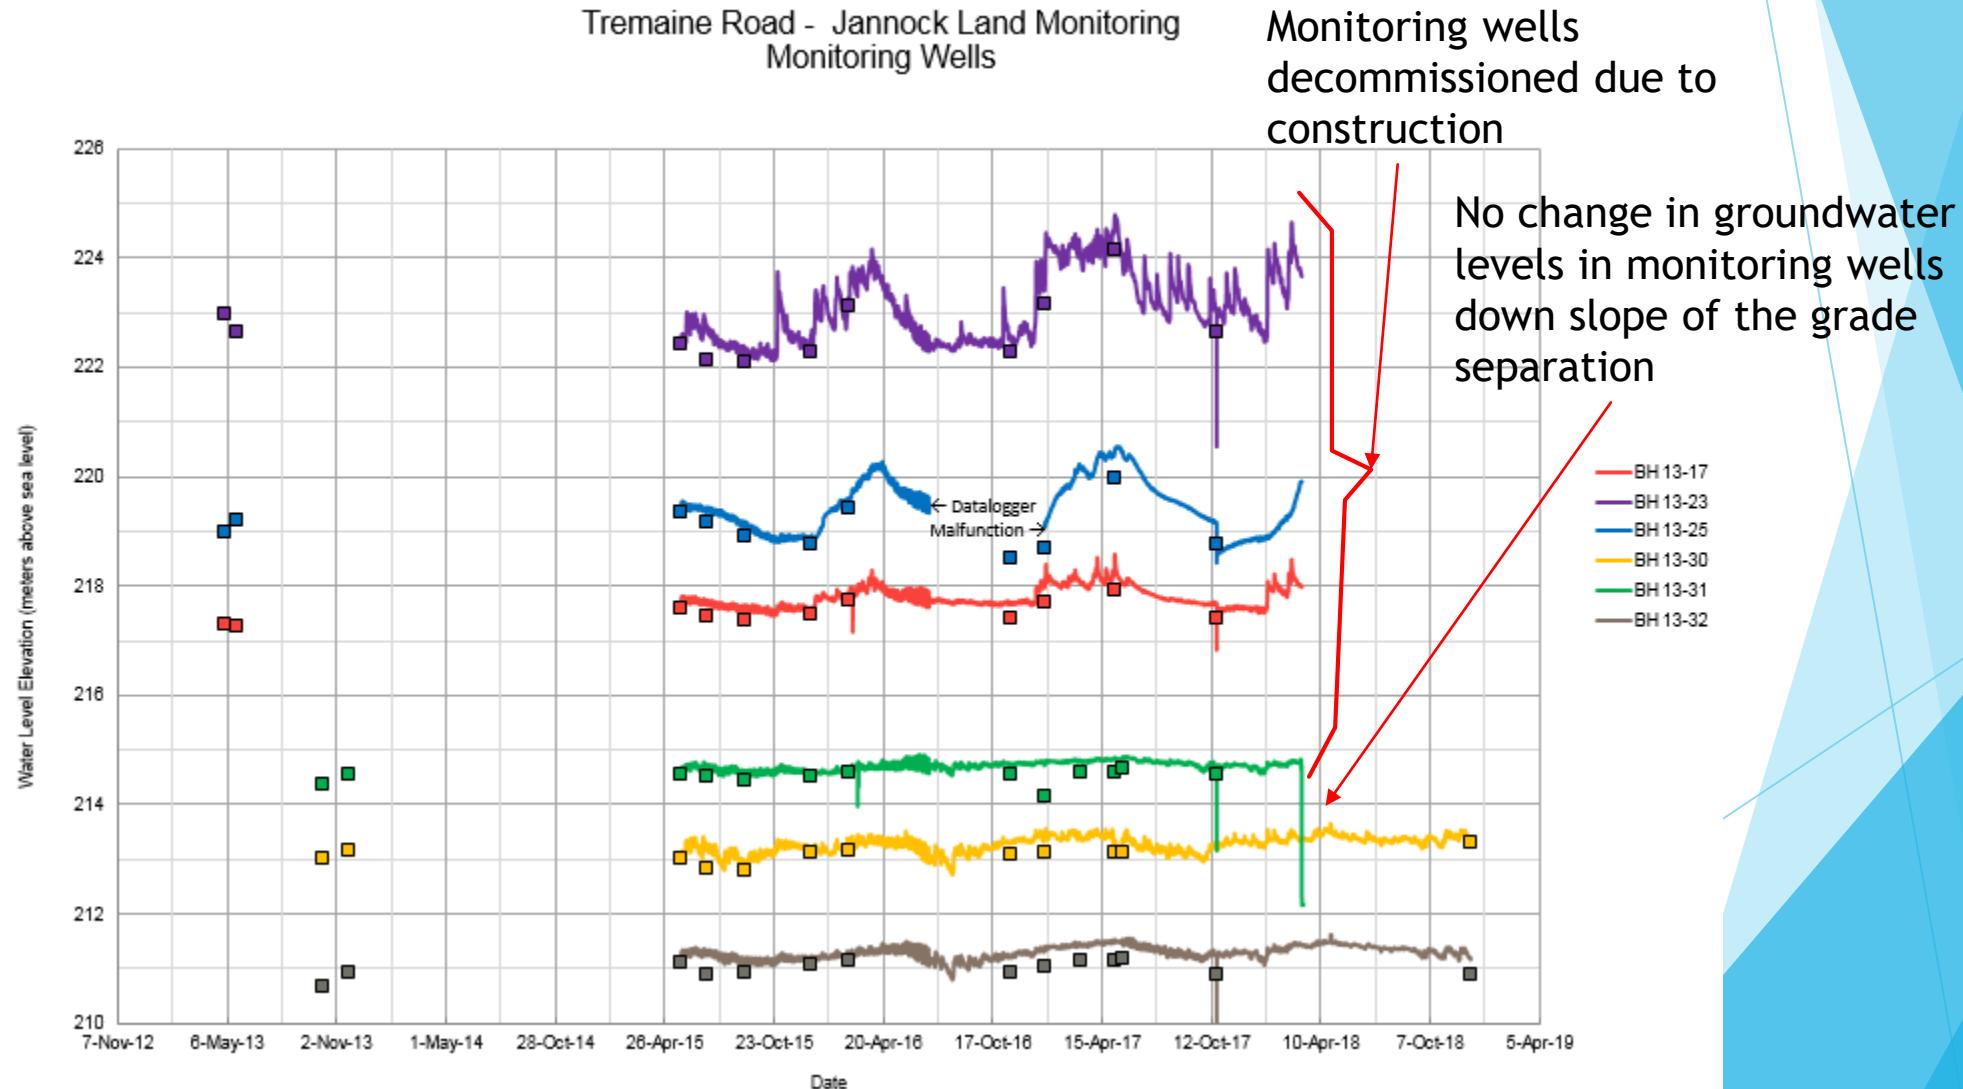
# Discharge Groundwater Downstream to Mimic Pre-Construction Conditions

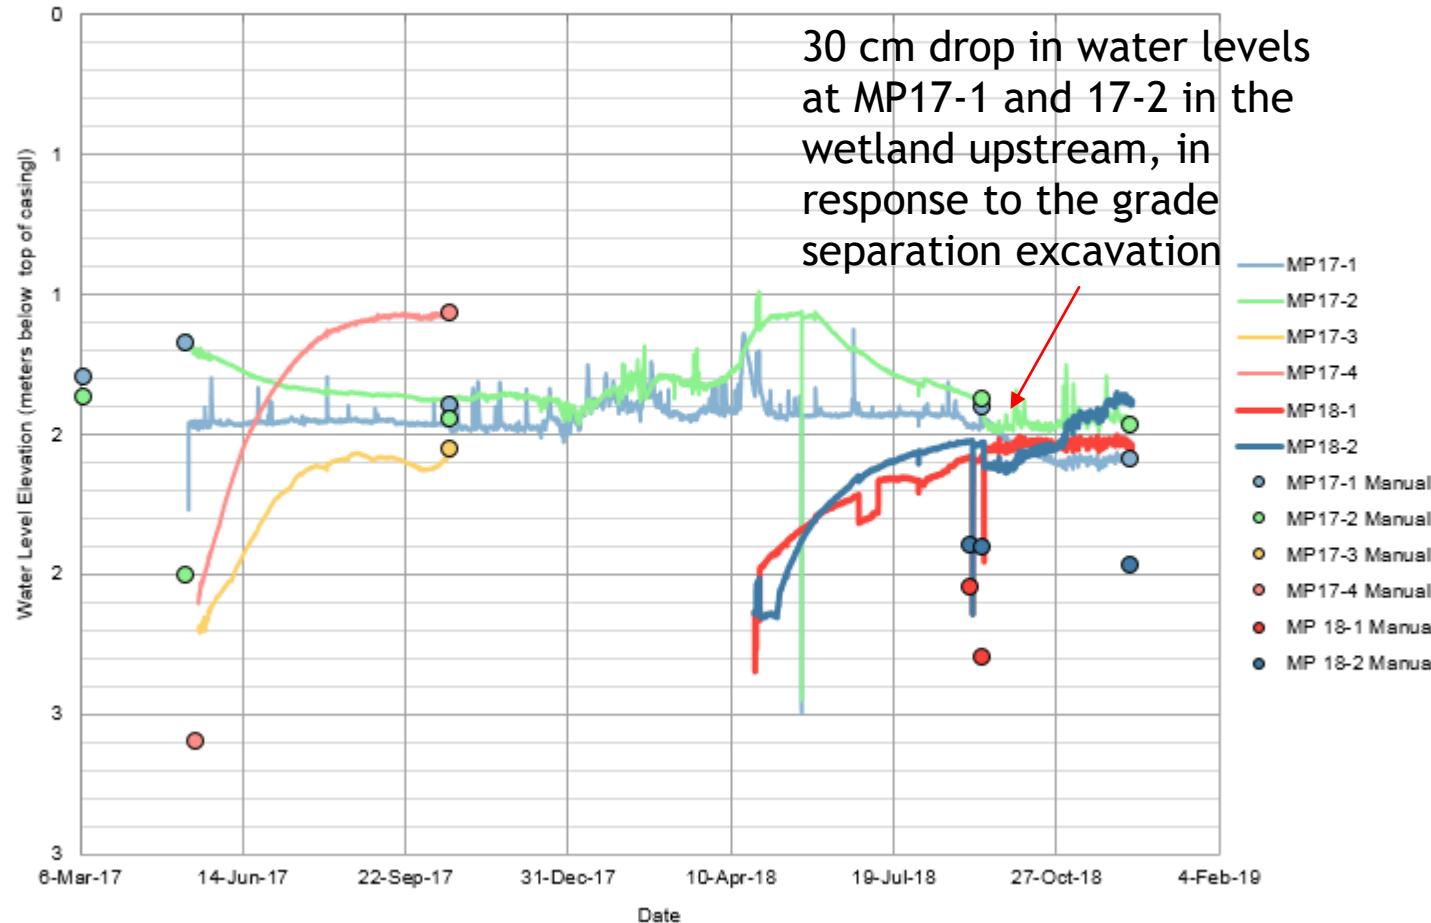
# Minimize Lowering Water Levels in Wetlands Upstream of the CPR Grade Separation

Tremaine Road - Jannock Land Monitoring  
Mini-Piezometers

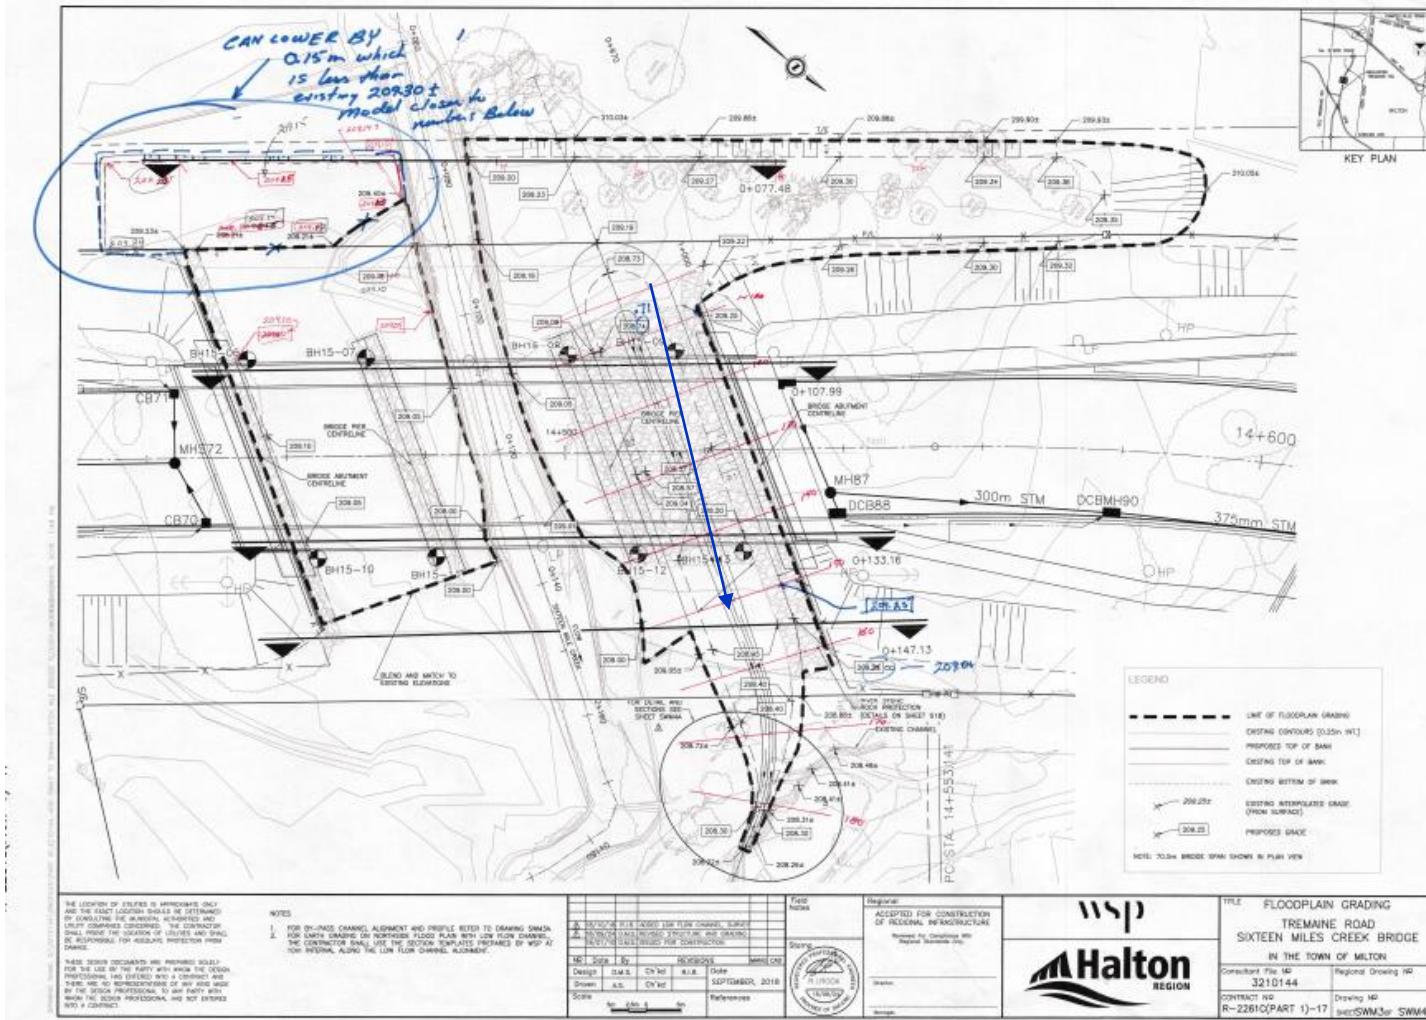
- ▶ By-pass channels created in the creek floodplain below the Tremaine Road bridge to increase conveyance of flood waters under the new bridge.

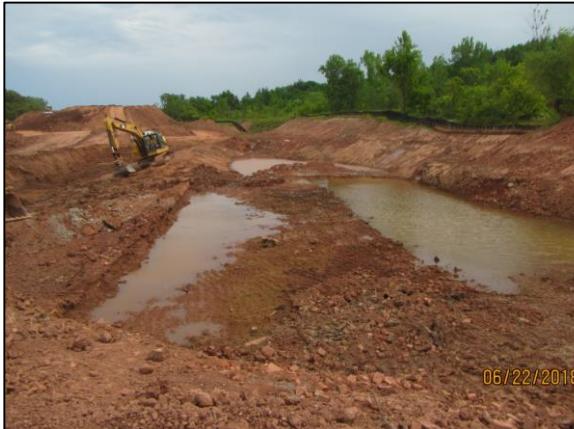
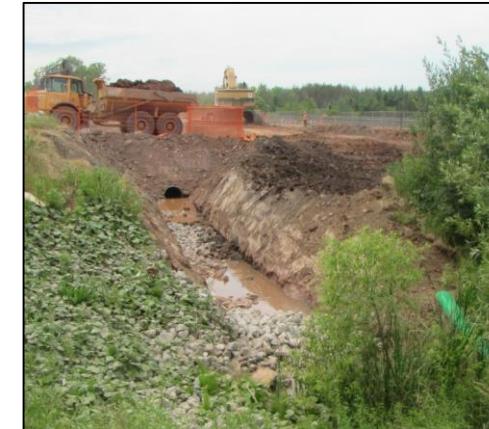
- ▶ Problem: Murky water in drainage channel draining the grade separation cut area

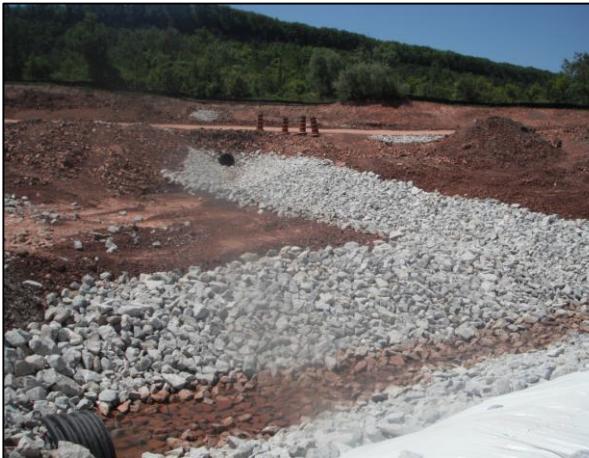
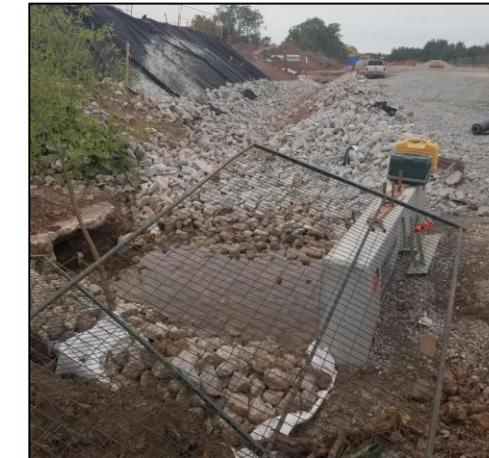
- ▶ Solution: Line the drainage channel with geotextile overlain by riprap
