# SOURCE FOR STREAM

Source to Stream, Brampton, ON  
Heather Amirault, P.Eng., CISEC  
March 22, 2023

## After the Landslide – A Field Fit Creek Restoration

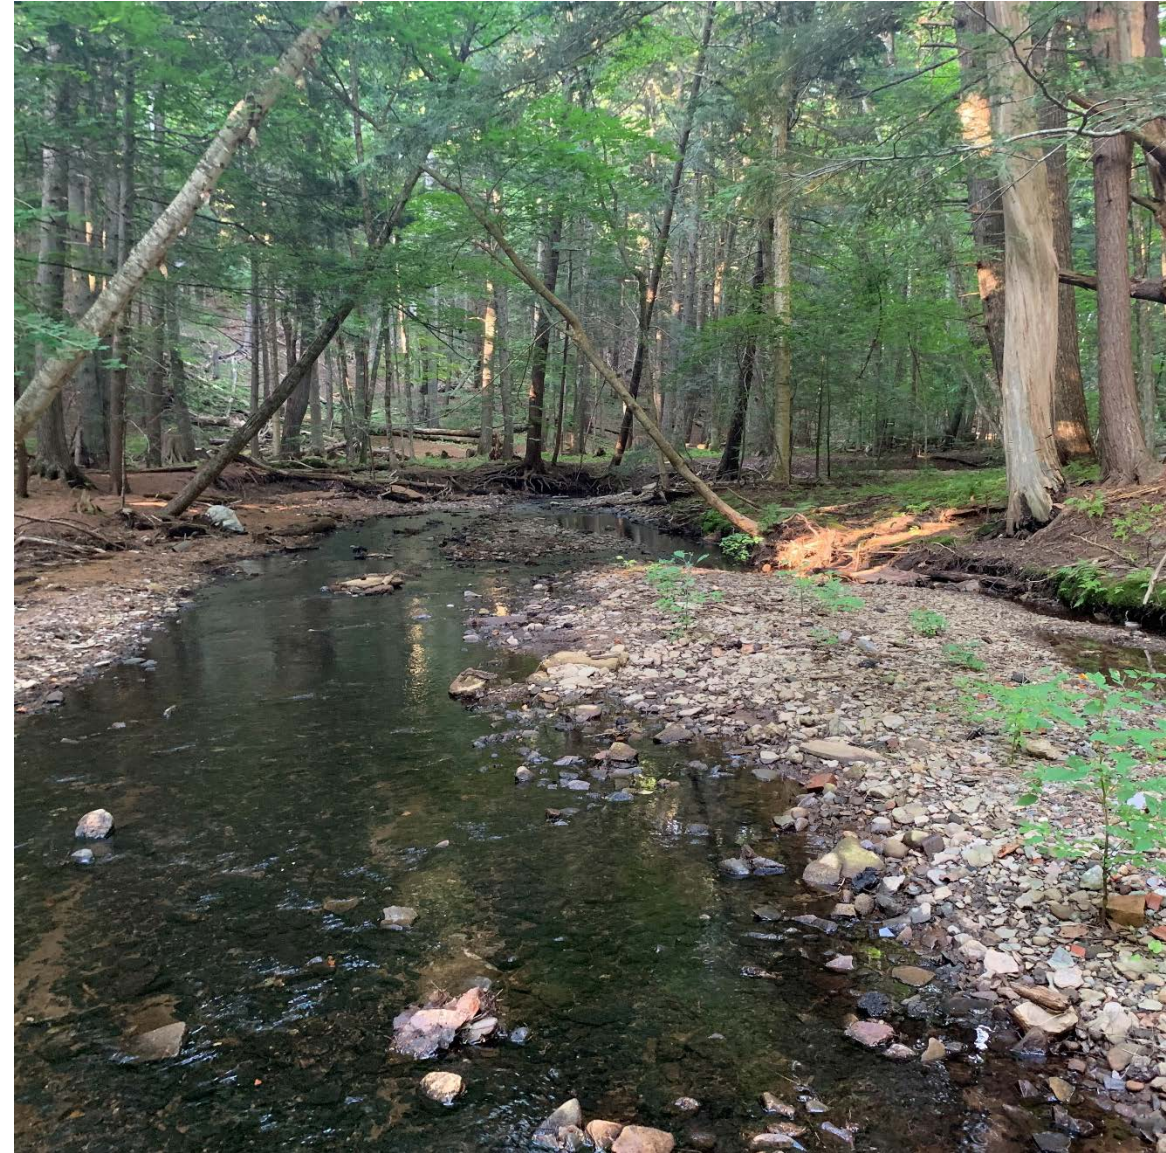
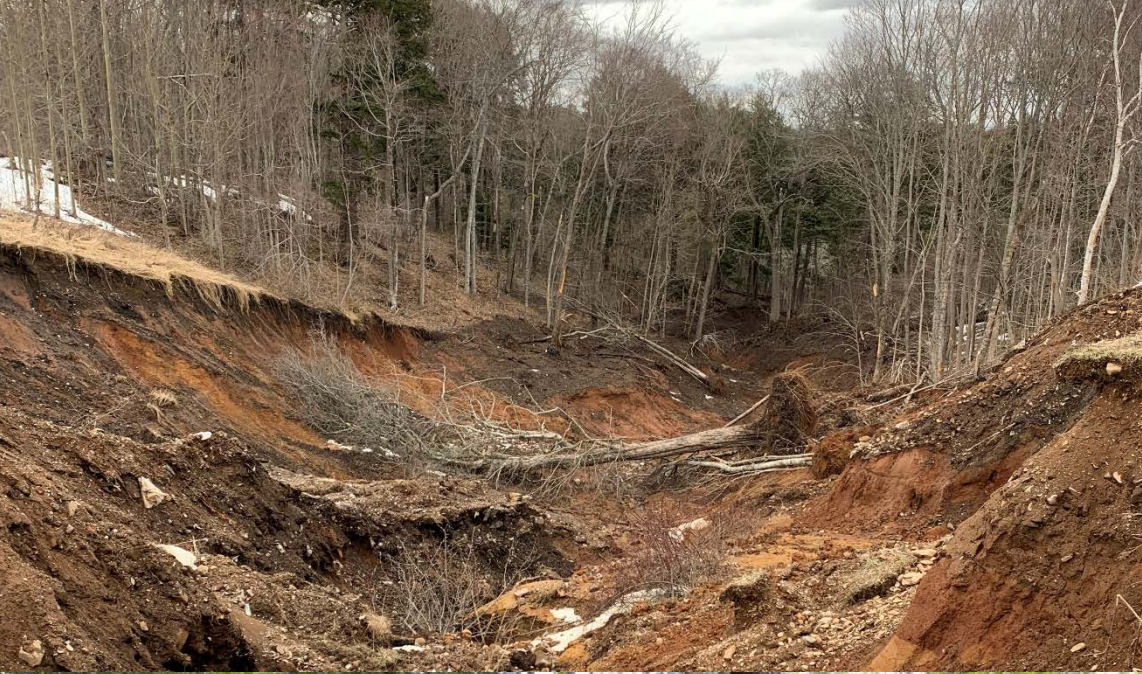
# Landslide

- Early Spring 2022
- Location of former landfill
- ~5000 m<sup>3</sup> of material
- Creates a swath of destruction
- Landslide debris dams Elderkin Brook

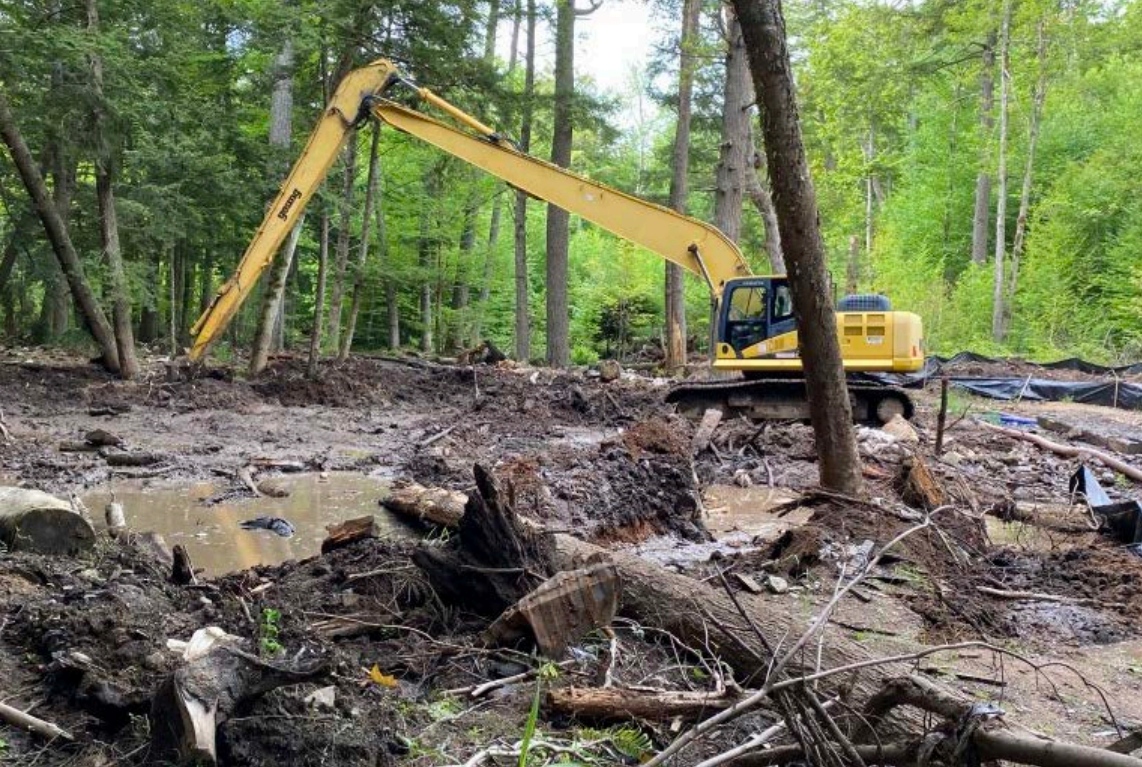
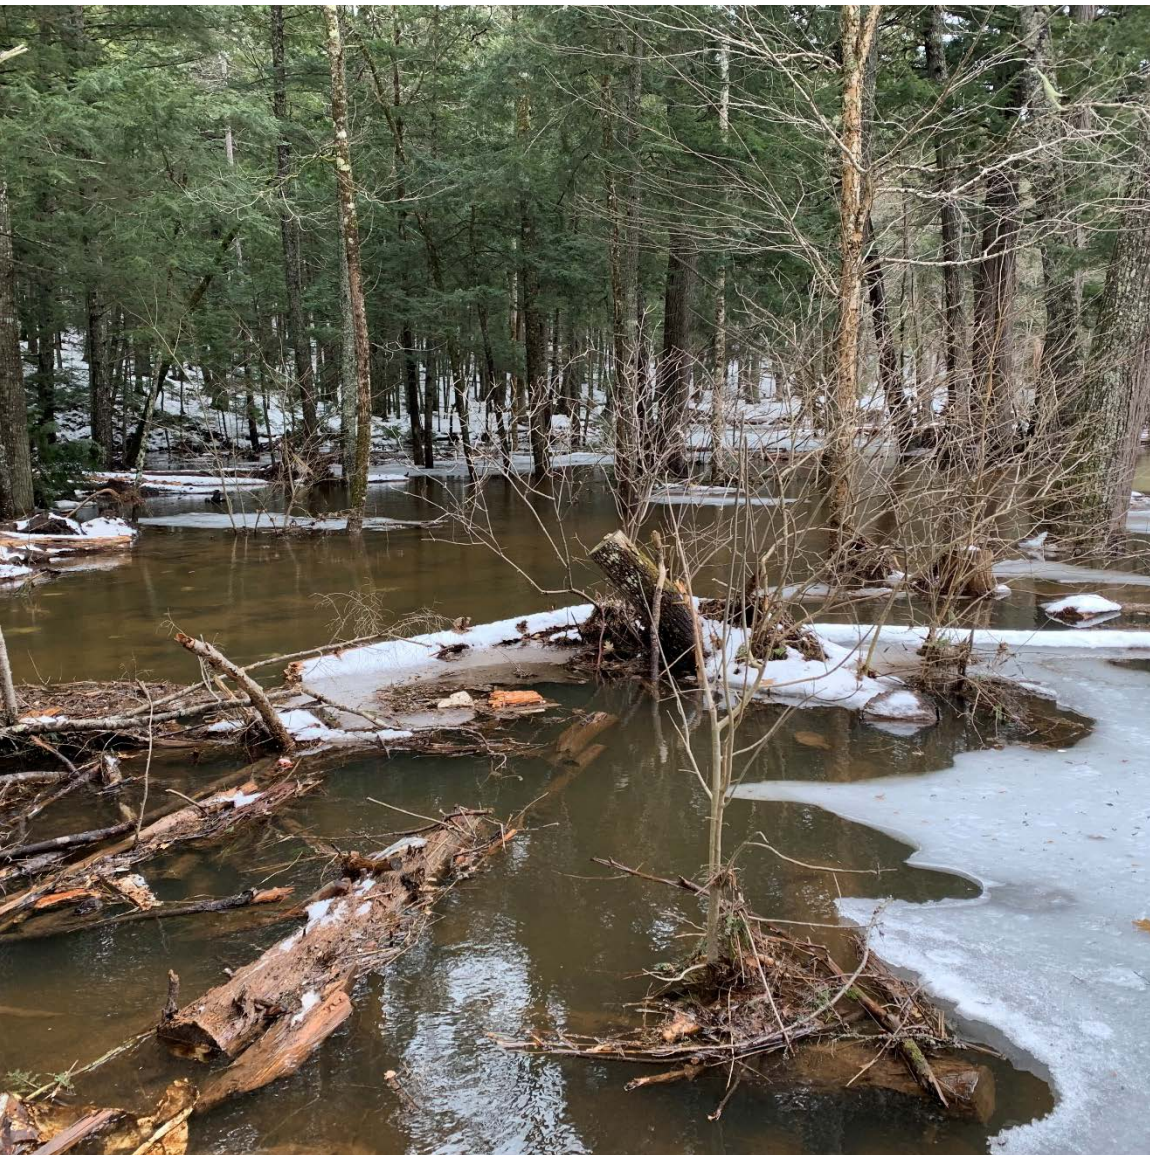
# Landslide

- Landslide dam creates large backwater
- Trail is gone
- Possible contamination from landfill
- No upstream fish passage
