An Urban Natural Channel Design Case Study

Converting Aging Concrete Infrastructure to a Natural Channel in Brampton

Presented by: Jeremi Madsen

March 26, 2024

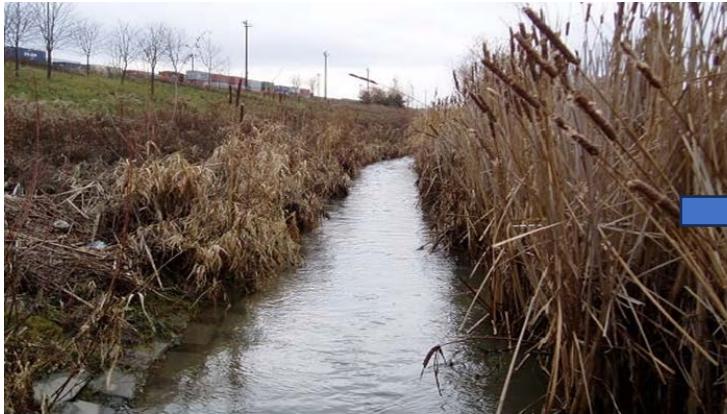
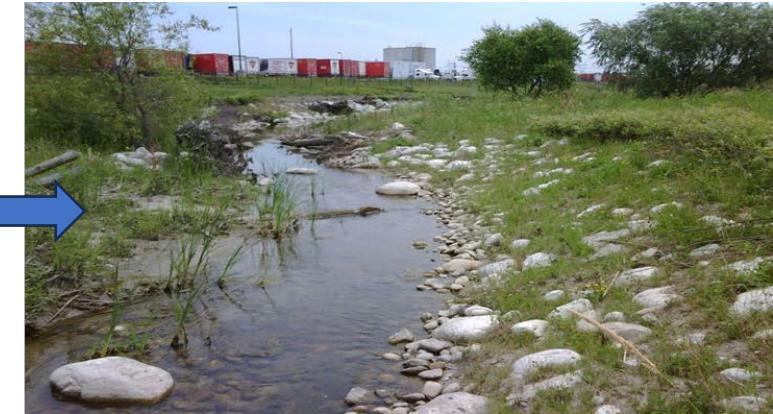
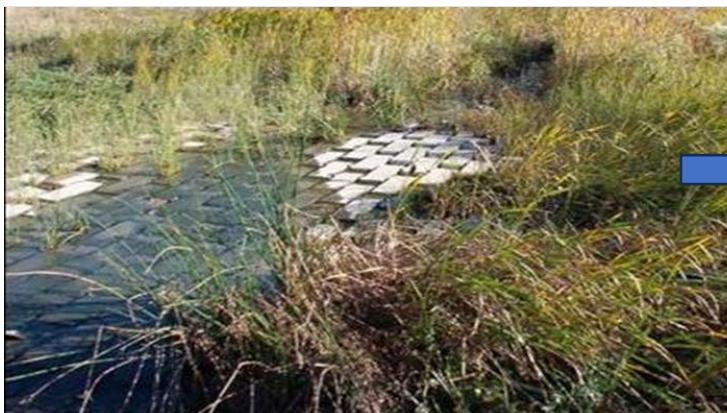
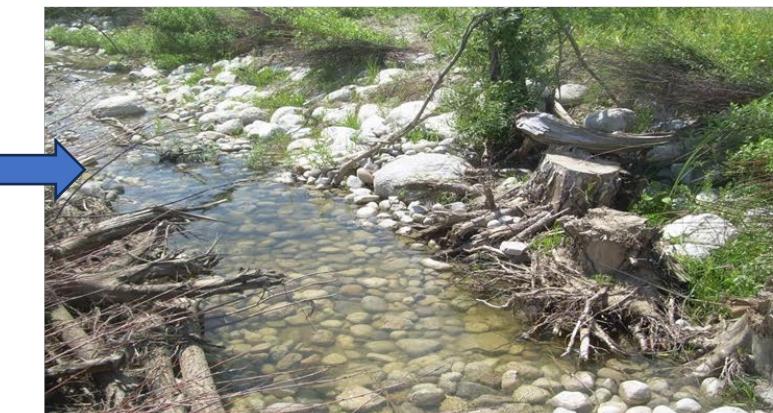
TRCA's Natural Channel Program: Upper Mimico (2007)

- Started with Upper Mimico stream restoration
- Channelized reach approximately 1200m long
- Hardened bank and bed treatments

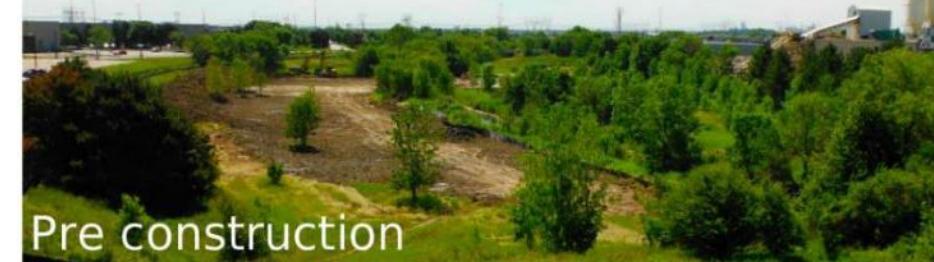
Pre construction

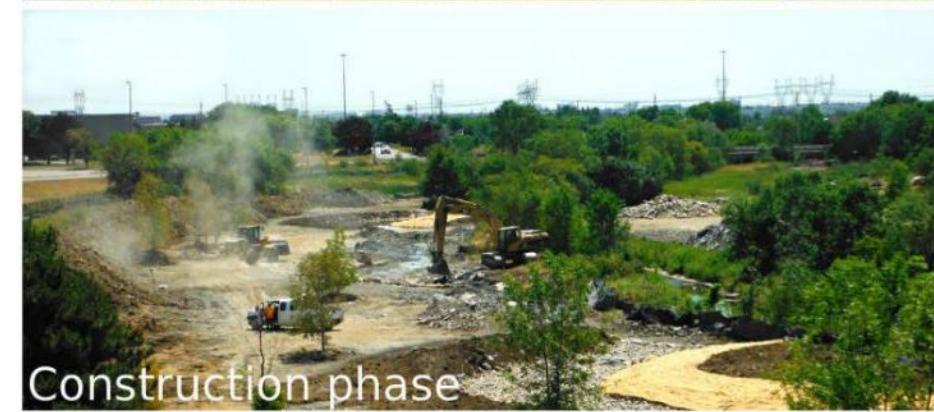
Construction phase

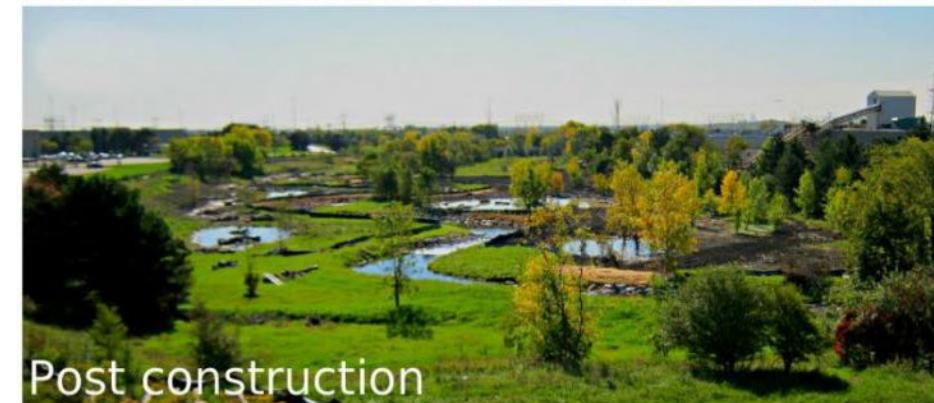
Post construction

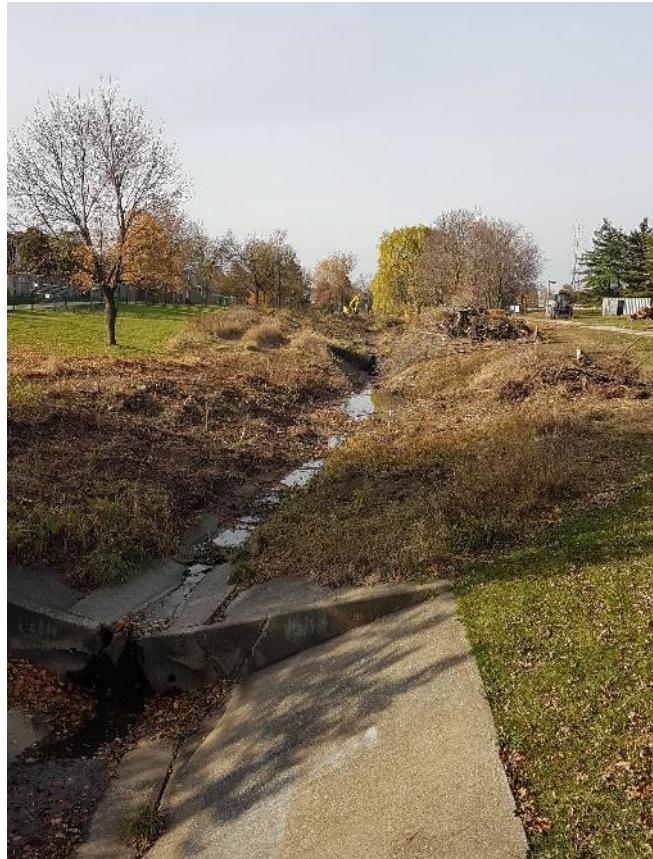
Channelized stream
before restoration

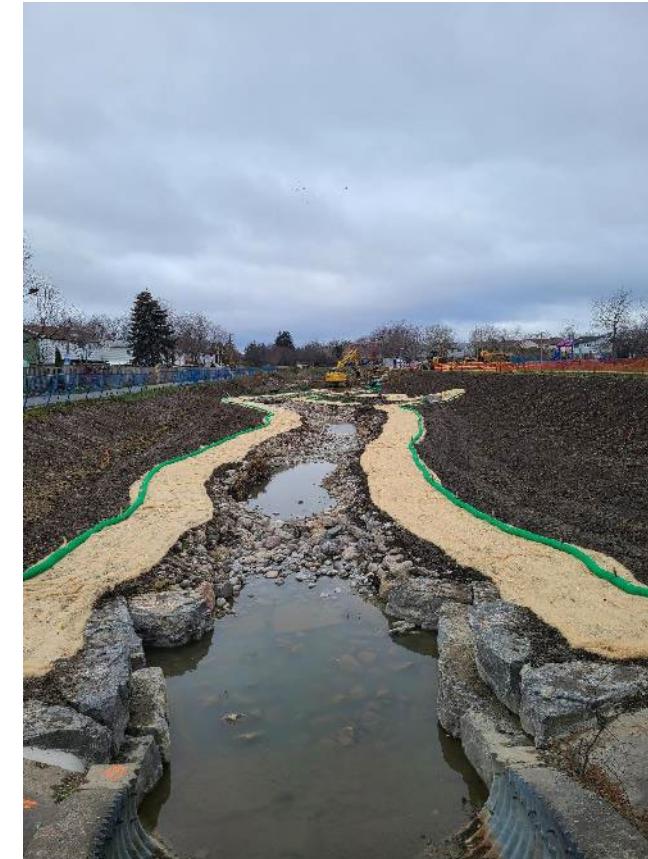
New channel
immediately post-
construction

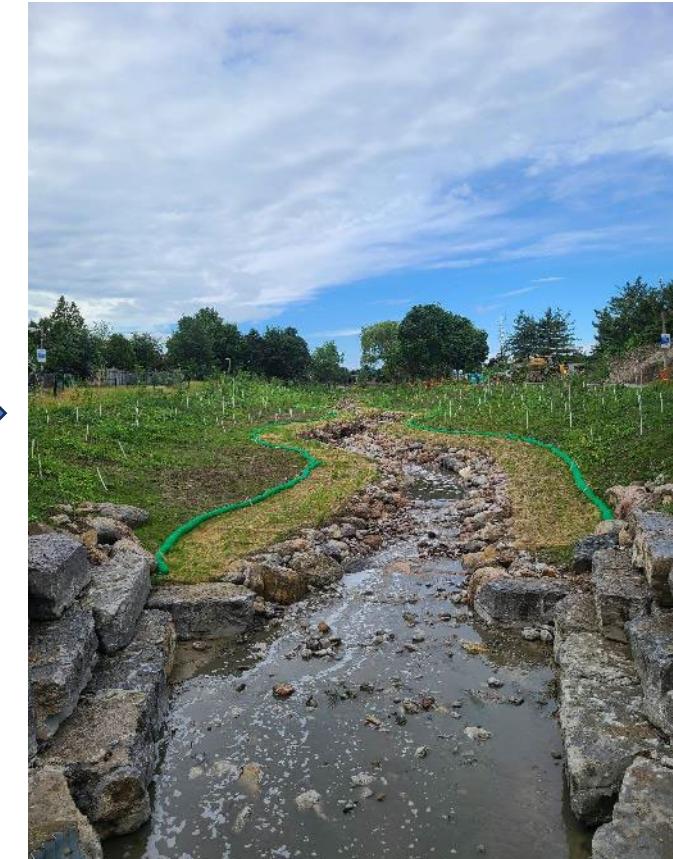
Restored channel
with native plantings
on banks

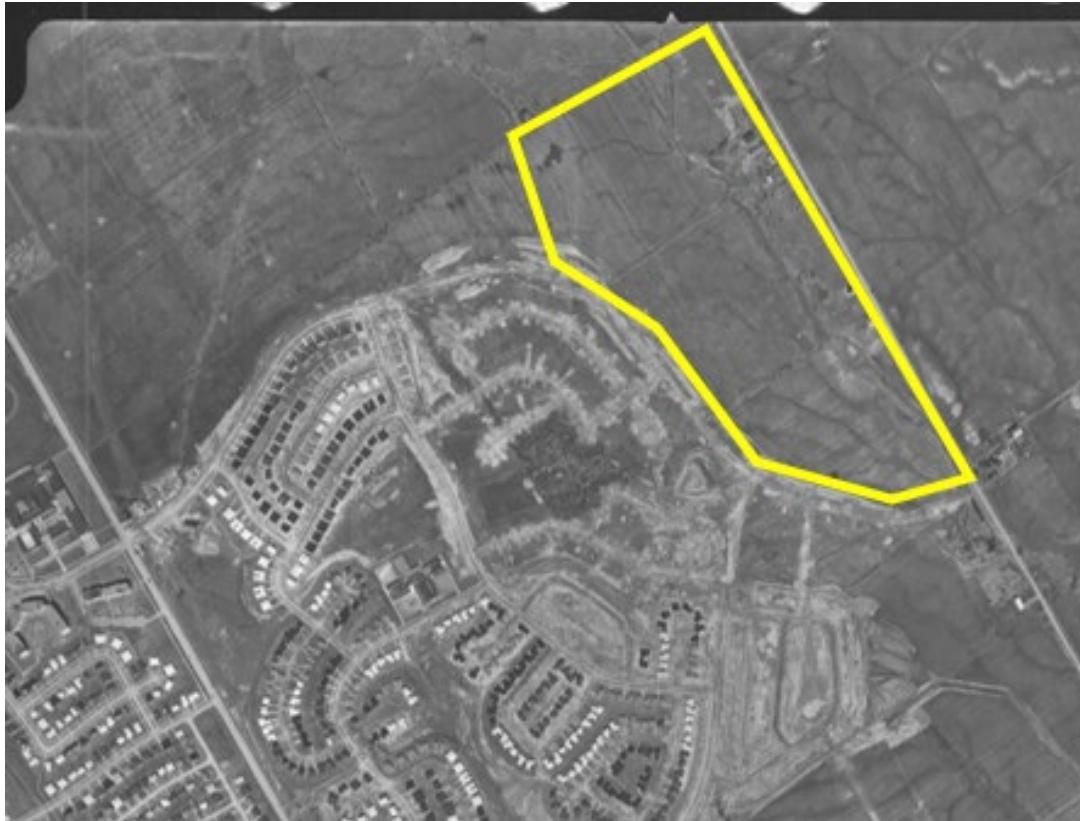
Eastbourne Park 1967

- Natural channel meandering through agricultural lands.
- Beginning of subdivision development.

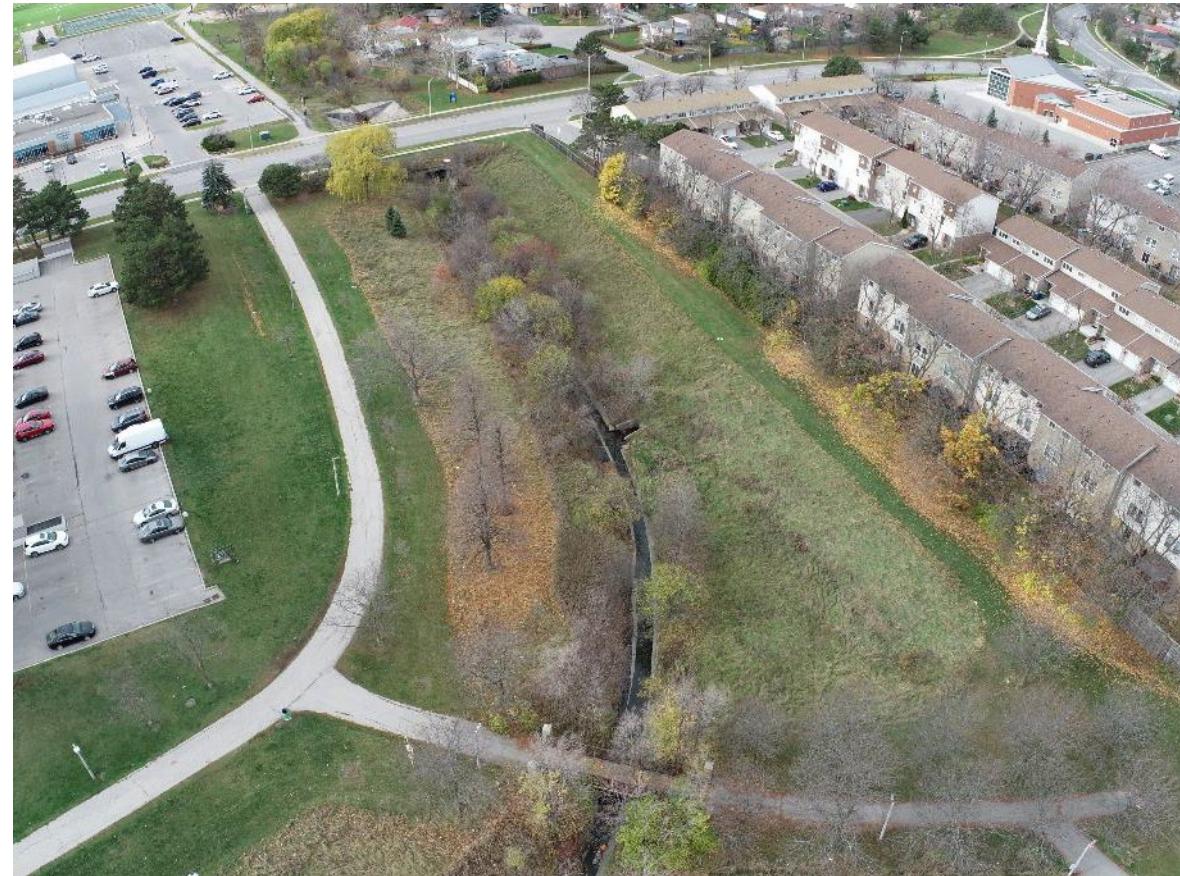
Existing Channel

- Bed and banks of much of the reach were hardened with concrete and concrete matting
- 12 concrete drop structures acted as barriers to fish passage
- Channel widening and active migration observed in areas that were unarmoured or where armouring had failed
- Elevated stormwater outfalls were undermined throughout the reach

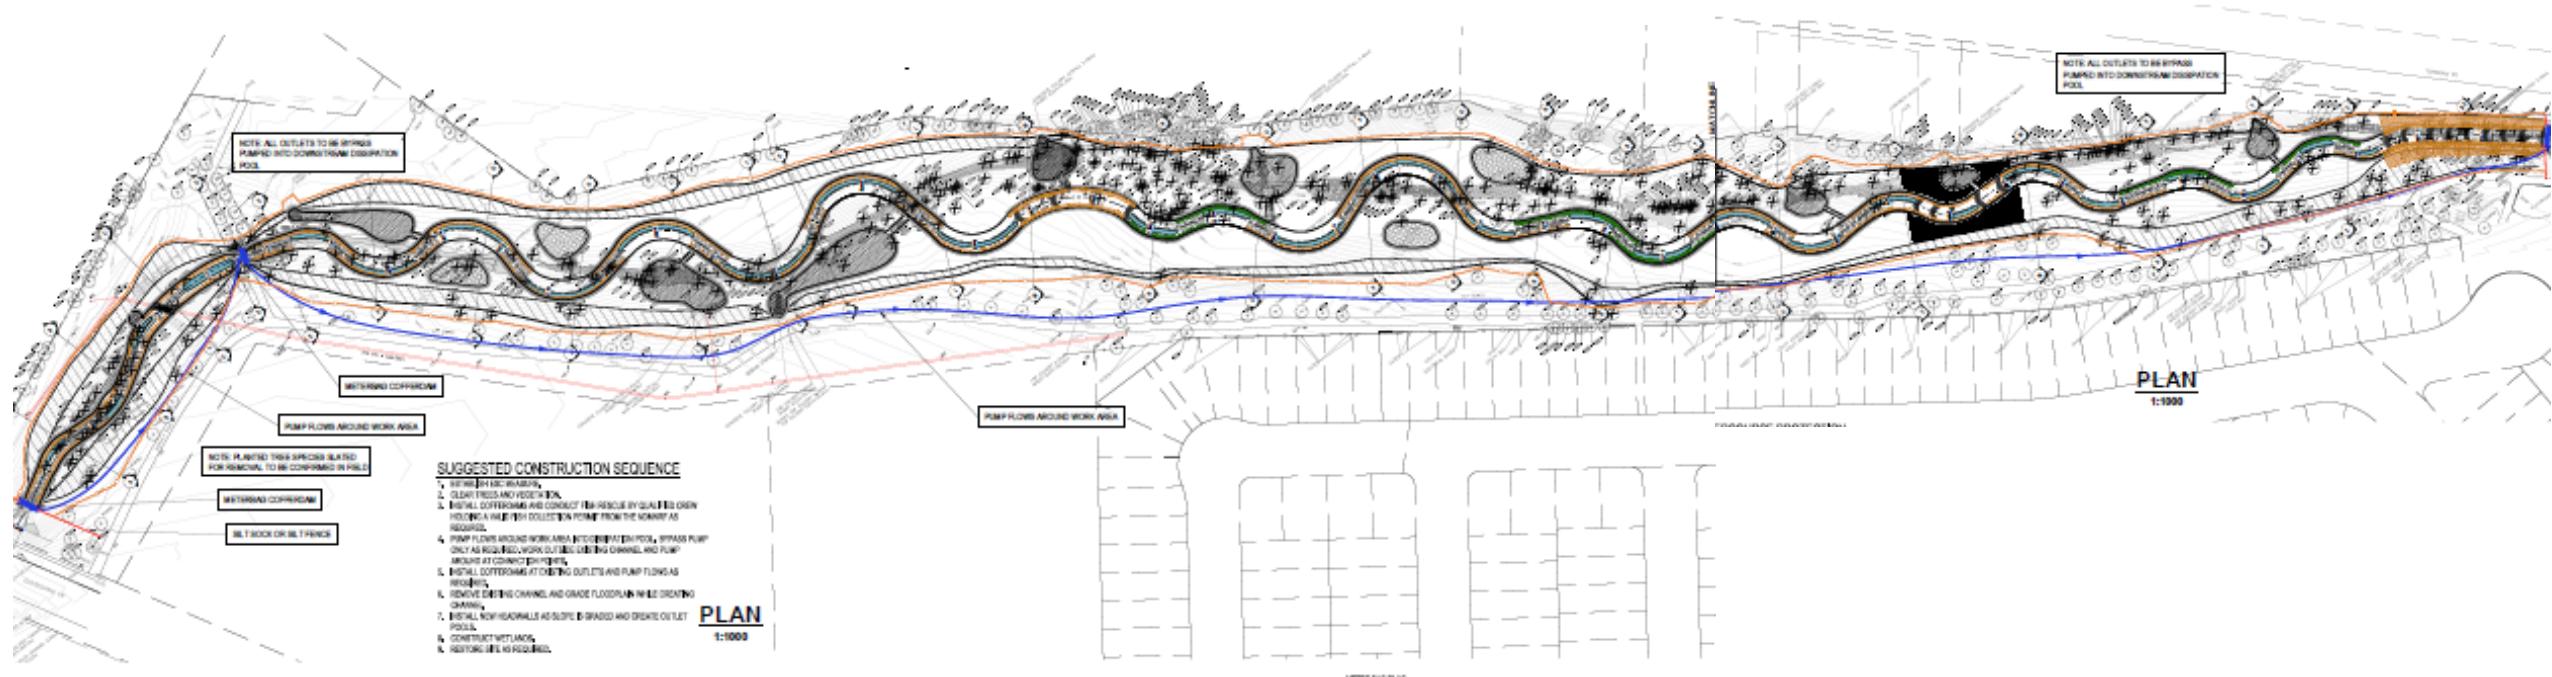
Design Drawings: Preferred Option

- Mitigation of the steep channel grade and dependence on weirs/drop structures through a meandering design.
- Improvement in aquatic habitat quality through riffles, pools, and streambank vegetation.
- Riparian wetlands and plantings provide the opportunity to incorporate additional habitat features (woody debris, bat snags, etc.)
- Increased connectivity of the channel with its floodplain resulting in improved floodwater management by riparian wetlands.
